# Broadcasters' Desktop Resource

### The 'ole Comtech Dish Just Ain't What She Used To Be

**By Alan Alsobrook**

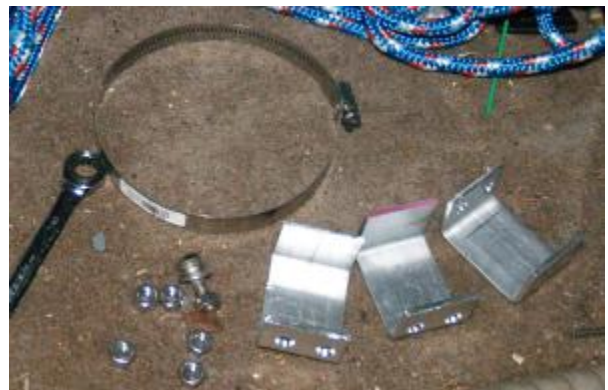
**The repair parts on the bench, at slightly less than \$1000**

First I cut out three 4-inch long sections and made two 90-degree bends, 1-inch from each end giving a C shape. I then predrilled one end of each of the three straps centering two holes 3/4-inch apart to match the existing holes in the feed arms.

One thing I will remember for the next dish repair I do is to make a ½-inch wide notch on each side of the C piece, where it mates with the feed horn. I would do that by cutting two slots about ¼-inch deep, and bending the tap towards the feed horn about 30°. This would give a place for the stainless steel strap to sit and lock the feed horn in place better.

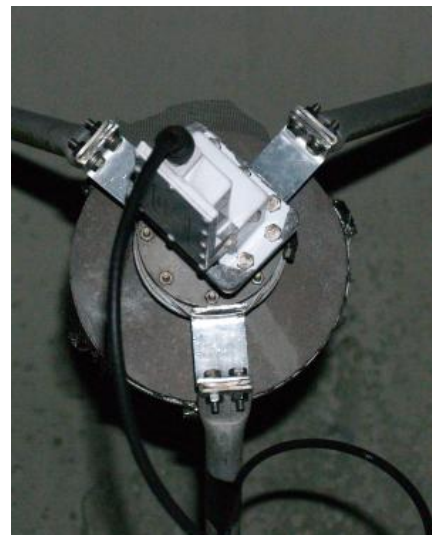
After getting the feed horn back in place, it is probably be a good idea to tweak up the LNB, and dish. You might note in the following picture that I somehow decided I would reinstall the LNB 90° off axis.

That does not work vary well. So let me repeat the part about taking a picture *before* you start. (I did not look at my pre-repair picture until after it did not work, oops!)
