Broadcasters' Desktop Resource

From The Transmitter Site Dialight LEDs Light the Broadcast Environment

By Rod Zeigler

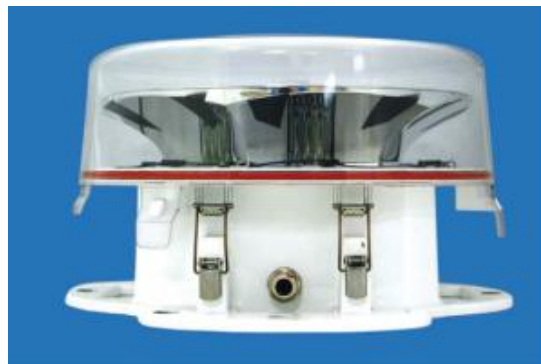
**A fourth generation beacon.
This model, a D464, uses 20 Watts to equal
the lighting from two incandescent lamps.**

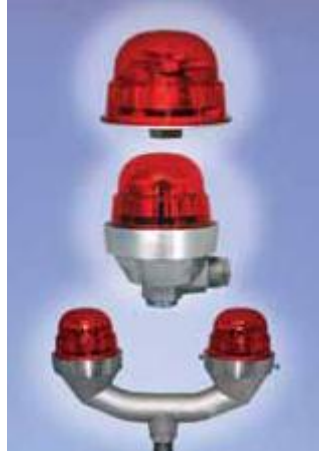
**The L810 RTO Series
draws 6.5 Watts of power.**

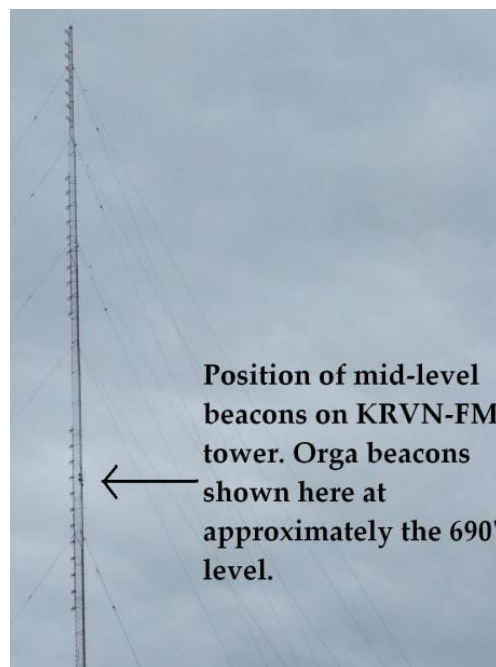
This tower has 3 separate, multi-bay, ERI Rototiller antennas on it - each for full C1 operation. The mid-level beacons are between, and on the back side of the tower from, elements four and five of the bottom, 12-bay ERI SHPX antenna.
