# Broadcasters' Desktop Resource

## The Worst I've Ever Seen!

### Part A into Part B - Interesting Fits

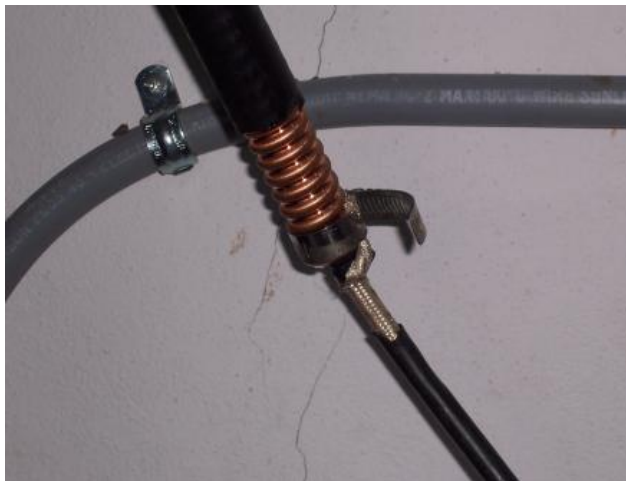
Terry Cowan saw the original picture, and sent this one to share. "I took this picture several years ago in the Caribbean," he writes. "The station was a Class A and, at the time, was running around 300 W TPO."

"Surprisingly, VSWR was low."

One can only look at this and, if not admire the mating of these two types of coax, at least respect that the guy probably had no Radio Shack nearby.

And the hose clamp did provide for a reasonably stable ground connection.

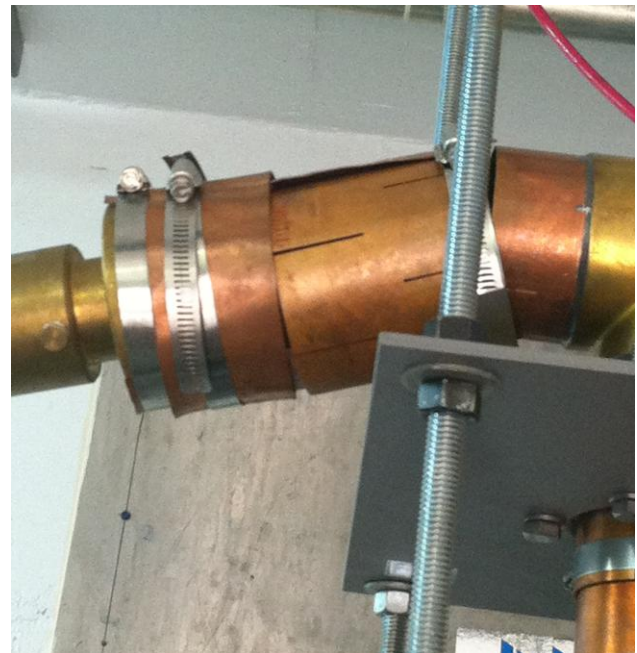
This next picture was the one Cowan saw that reminded him of his Caribbean trip. Also in the Caribbean, Craig Bowman took this one was at a station normally running a PT-20.

The main transmitter was off the air, as was the auxiliary transmitter. When Bowman arrived, a Crown 150 translator had been "fitted" to the feed line to put a signal on the air.

The transmitter was connected to the rigid line via a series of bullets, reducers, adapters, and covers. It was almost worthy of a Rube Goldberg award.

But again, just as with the one Cowan saw, in the end, Bowman had to acknowledge the local guy had actually done a good job in getting the RF to the antenna. The station was on the air!

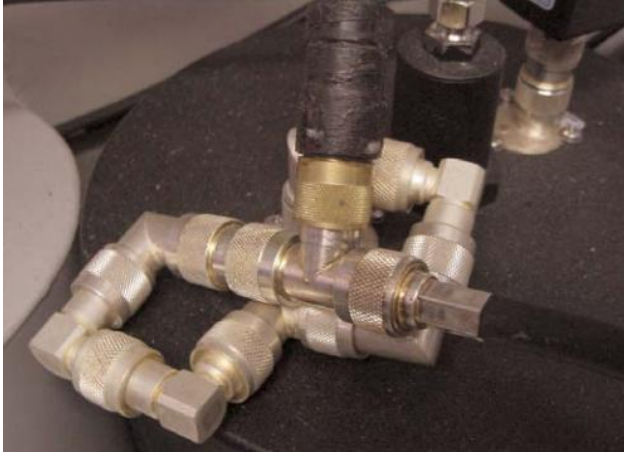
The picture was taken at a mountaintop transmitter site where several two-way antennas were in close proximity and, according to the engineer, the feed line shown needed some attenuation.

Since each connector will cause a small insertion loss, it is possibly understandable that the engineer felt he had to use every connector in his toolbox to bring the RF down.

But it also seems the concept sort of got away from him – it is a bit puzzling that he never got rid of the connectors and installed a proper RF attenuator.
