The  
**Broadcasters' Desktop Resource**

## Tech Tips

### Death by Capacitor

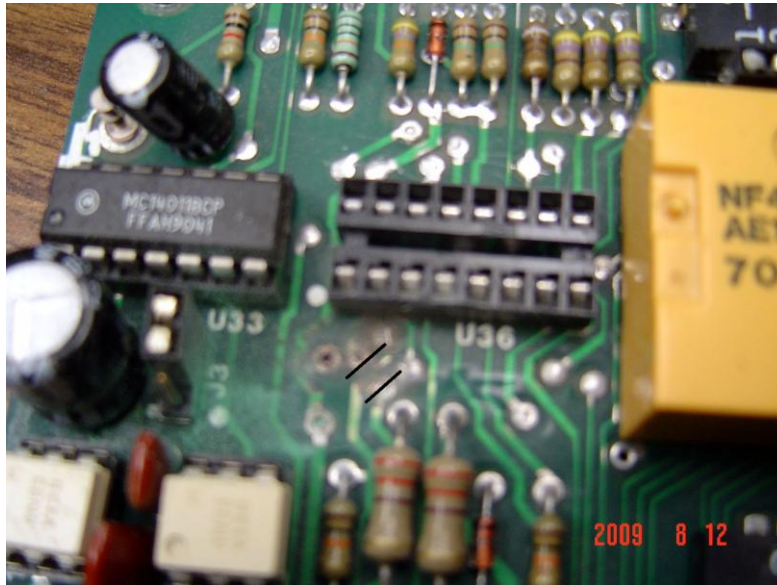
Finally, checking the 100 uF capacitor, I found it measuring only 74 uF. A closer inspection showed the capacitor had spilled its contents and eaten away a trace on PC board.

This trace was connected to the mute signal to stop Day/Night adjust switch selection. In fact, the trace was eaten completely open! This is a case where the capacitor's chemical leakage actually ate away the foil path. Failure was from the chemical action; the picture shows the damage.

Solving the problem entailed cleaning the pc board and replaced the missing trace for mute disable. It appears the 2004 IC was damaged, but the affect is to status LED and did not affect the relay switch.

The lesson learned is electrolytic capacitors need to be changed out after ten service years - and must be done at 15 years even if the gear still appears to be working. The danger is not just the loss of component value but the goo oozing out from bad capacitors. For this unit it is clearly time to blitz all the capacitors
