## **Tech Tips**

**By Warren Shulz**

# **The Dangers of Leaving "Well Enough" Alone**

### **DOWN IN DRIVE TIME**

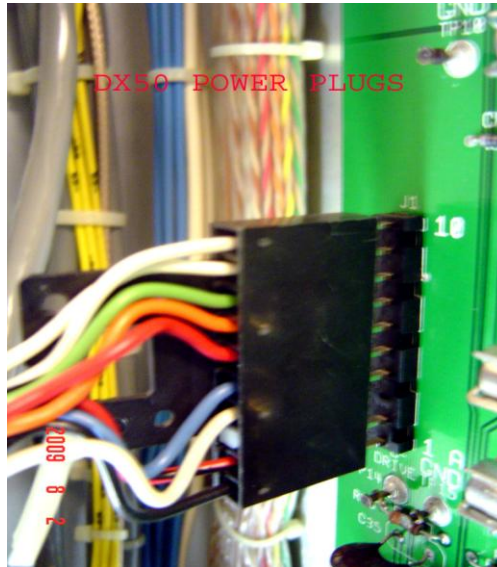
Following the circuit path, I moved connector J6 (on the DC regulator) and the B side voltage quickly changed back to a normal reading, stabilizing at 4.72 VDC.

It seemed apparent that the issue was related to the connector, although these tin plate connectors have large surfaces and you would never think of them being erratic. Good contact is important: these bias voltage-level tests are critical shutdown points if the FET power PA amplifier bias is not correct. Their purpose is to protect the 1,024 FET devices from failure - as in *all of them could be destroyed!* - because of a bias fault.

**The plug would have benefitted from a bit of exercise over the years**

Basically, I suspect the connection became erratic over time and the comparator simply switched off. This was a good find and should be a warning that connectors that have not been moved for years can become a source of intermittent faults. I would suggest making it a part of the yearly maintenance plan.

The repair process was simple. I cleaned all the tin plate connectors in the front of the PA modules, wiping them with gold wipe chemical cloth, and then treating them with DeoxIT D100L by Caig - a contact lubricant and preserver. Afterward, it was clear that the connectors moved on-off with less friction than before. (Other ribbon connectors in the DX-50 are gold on gold and would be more stable.)
