The
Broadcasters' Desktop Resource

Tech Tips

The Dangers of Leaving "Well Enough" Alone

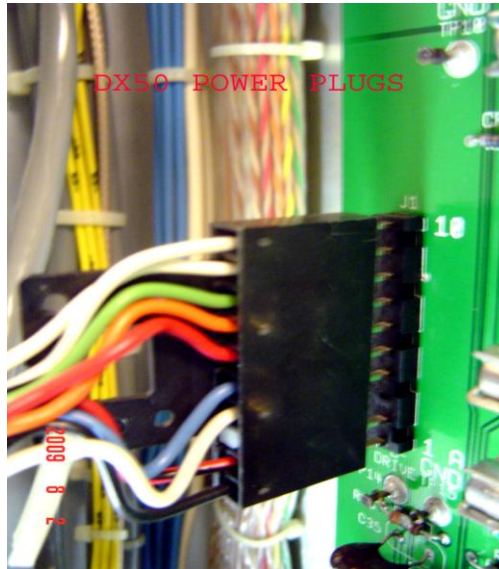
Following the circuit path, I moved connector J6 (on the DC regulator) and the B side voltage quickly changed back to a normal reading, stabilizing at 4.72 VDC.

It seemed apparent that the issue was related to the connector, although these tin plate connectors have large surfaces and you would never think of them being erratic. Good contact is important: these bias voltage-level tests are critical shutdown points if the FET power PA amplifier bias is not correct. Their purpose is to protect the 1,024 FET devices from failure - as in *all of them could be destroyed!* - because of a bias fault.

The plug would have benefitted from a bit of exercise over the years

Basically, I suspect the connection became erratic over time and the comparator simply switched off. This was a good find and should be a warning that connectors that have not been moved for years can become a source of intermittent faults. I would suggest making it a part of the yearly maintenance plan.

The repair process was simple. I cleaned all the tin plate connectors in the front of the PA modules, wiping them with gold wipe chemical cloth, and then treating them with DeoxIT D100L by Caig - a contact lubricant and preserver. Afterward, it was clear that the connectors moved on-off with less friction than before. (Other ribbon connectors in the DX-50 are gold on gold and would be more stable.)
