# **Broadcasters' Desktop Resource**

### **The 'ole Comtech Dish Just Ain't What She Used To Be**

**By Alan Alsobrook**

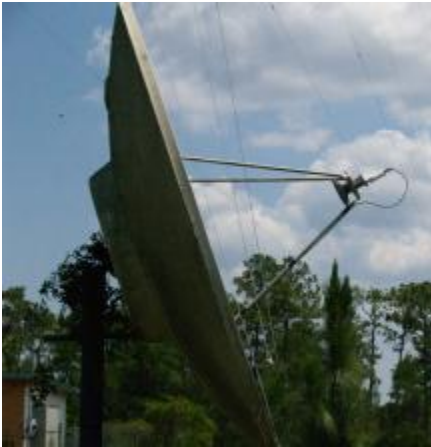
What happens is that the material used in the plate has been attacked by Ultra Violet light over the years and, eventually, it just starts falling apart. If you have not checked your mount regularly, your first warning is likely to be loss of signal on all satellite receivers connected to that dish. If that happens to be your only dish, it is not going to be a good day.

A visual inspection quickly confirmed the problem, when I saw the feed horn pointing below the center of the dish.

**The feed horn is askew in relation to the dish**

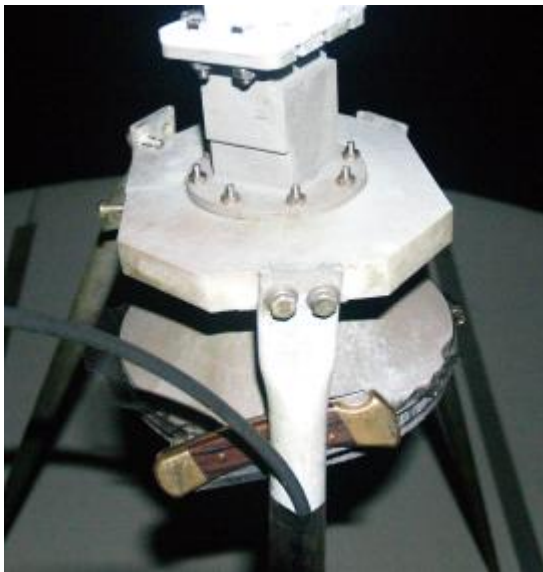
**Temporary measures got the signal back**

Careful placement of my trusty old Buck knife was able to restore a missing program feed until I could make more permanent repairs.

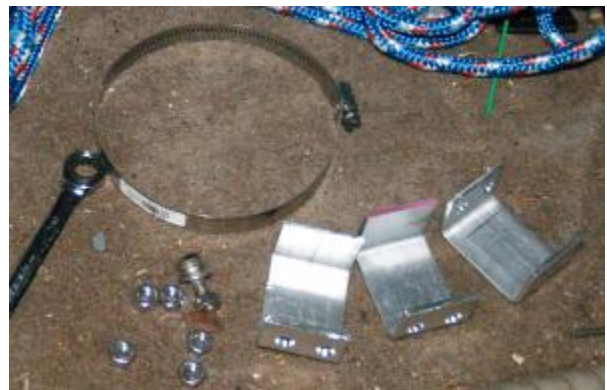
**The repair parts on the bench, at slightly less than \$1000**

First I cut out three 4-inch long sections and made two 90-degree bends, 1-inch from each end giving a C shape. I then predrilled one end of each of the three straps centering two holes 3/4-inch apart to match the existing holes in the feed arms.

One thing I will remember for the next dish repair I do is to make a ½-inch wide notch on each side of the C piece, where it mates with the feed horn. I would do that by cutting two slots about ¼-inch deep, and bending the tap towards the feed horn about 30°. This would give a place for the stainless steel strap to sit and lock the feed horn in place better.

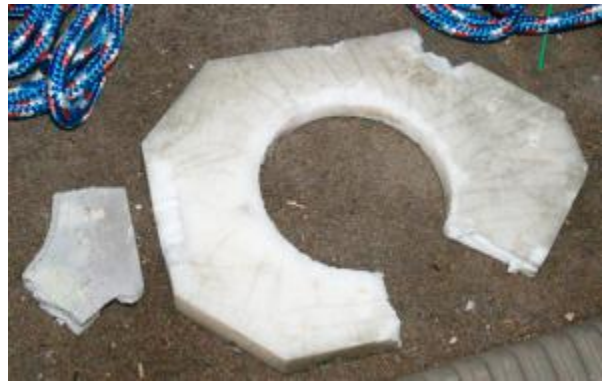
After a bit effort I was finally able to break out a section and remove the feed horn. A hack saw would likely make the job much easier. Once I got the feed horn on the bench and disassembled everything, the problem with the broken mounting plate was obvious.

**This mounting plate was not going to be of much use**

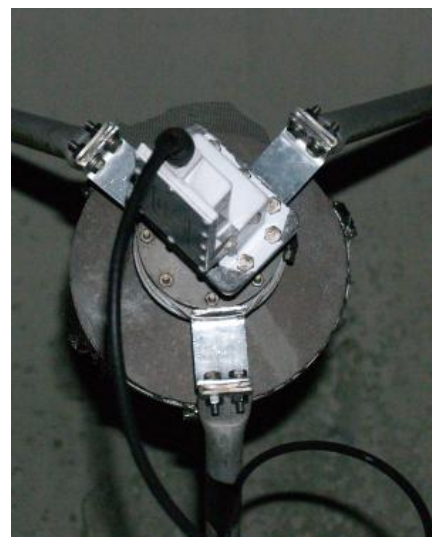
After getting the feed horn back in place, it is probably be a good idea to tweak up the LNB, and dish. You might note in the following picture that I somehow decided I would reinstall the LNB 90° off axis.

That does not work vary well. So let me repeat the part about taking a picture *before* you start. (I did not look at my pre-repair picture until after it did not work, oops!)
