# **Broadcasters' Desktop Resource**

## **The Maintenance Shift** **Unexpected Changes – Now What?**

*[December 2018] In an era when many transmitter sites are visited infrequently, most good radio engineers pay close attention to operating parameters. When something happens, how one proceeds is important – and how fast. Waiting until there is “smoke” can be very expensive in the end. Clay Freinwald explains.*

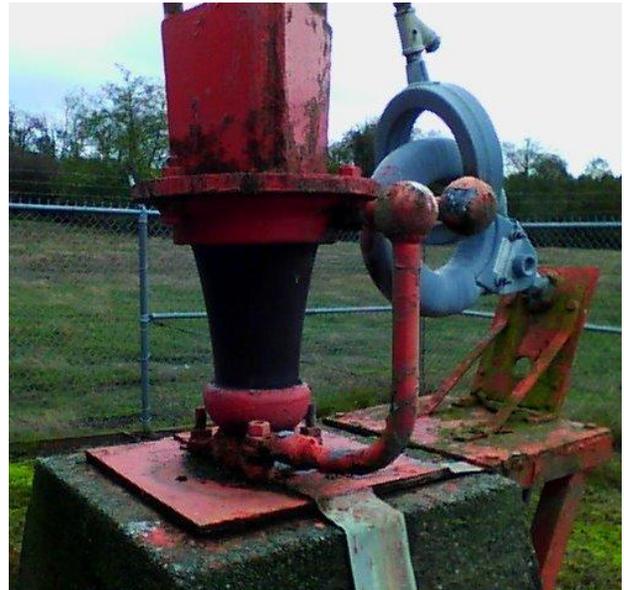
Shown here is the base insulator of Tower #3:

All looked, on the surface, to be “normal.”

Now, in Stevens own words, what happened next: *“At the base of the tower above the insulator there is about a one foot well with drain holes on four sides, moss and debris had blocked the drain holes above the insulator. In this well we found a partially decomposed rat and an old bee hive.*

*“On the insulator, there is a stainless steel plate, glued with Mastic material to seal the hole used to access the void in the insulator.*

*Upon inspection, it looked like rain water pooled and may have found its way past the mastic material into the void, filling it up. We also found out that condensation can build up in the void if the drain hole is plugged.*

Using a wire brush and custom fabricated poker made out of #12 copper wire, they found the drain hole that had been plugged with debris. When cleared, the water within the bases insula-

tor drained fairly rapidly. Thankfully, a close inspection of the insulator showed it was not cracked or otherwise mechanically compromised which would have led to more issues

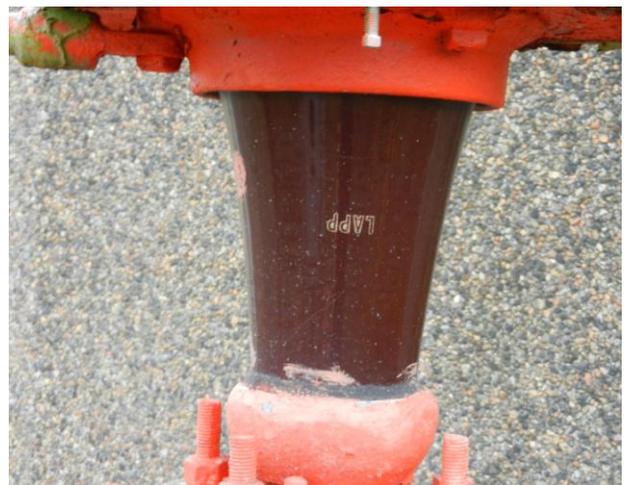
And, here is a closer view”

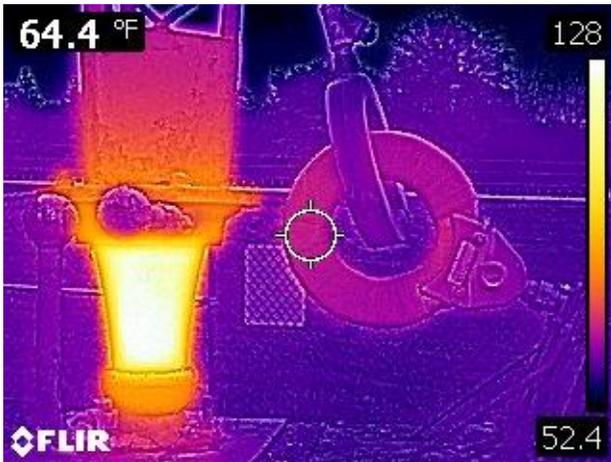
Interestingly, both Bonneville and IHeart now had them, and soon brought them out to the site. The thermal images clearly showed the insulator was getting just a bit warm.

Notice the temperature scale on the right
