Tech Tips

By Warren Shulz

Death by Capacitor

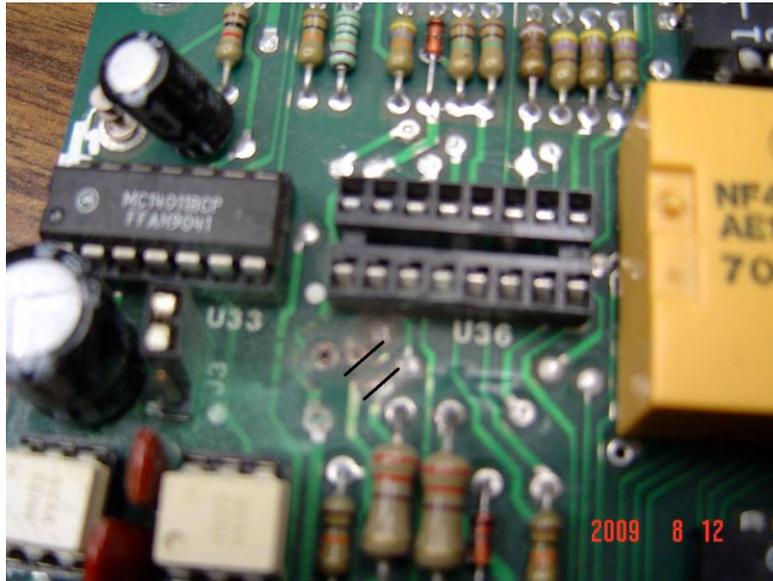
Finally, checking the 100 uF capacitor, I found it measuring only 74 uF. A closer inspection showed the capacitor had spilled its contents and eaten away a trace on PC board.

This trace was connected to the mute signal to stop Day/Night adjust switch selection. In fact, the trace was eaten completely open! This is a case where the capacitor's chemical leakage actually ate away the foil path. Failure was from the chemical action; the picture shows the damage.

Solving the problem entailed cleaning the pc board and replaced the missing trace for mute disable. It appears the 2004 IC was damaged, but the affect is to status LED and did not affect the relay switch.

The lesson learned is electrolytic capacitors need to be changed out after ten service years - and must be done at 15 years even if the gear still appears to be working. The danger is not just the loss of component value but the goo oozing out from bad capacitors. For this unit it is clearly time to blitz all the capacitors
