# Broadcasters' Desktop Resource

## From The Transmitter Site Dialight LEDs Light the Broadcast Environment

**By Rod Zeigler**

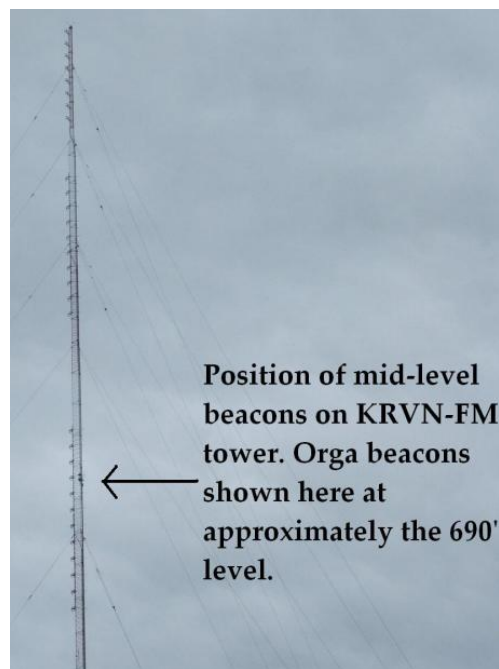
This tower has 3 separate, multi-bay, ERI Rototiller antennas on it - each for full C1 operation. The mid-level beacons are between, and on the back side of the tower from, elements four and five of the bottom, 12-bay ERI SHPX antenna.

By shutting down the transmitter for the bottom antenna, we could get the mid-level beacons to start again, and they would stay that way when the transmitter was restarted. As the weeks went by the time they stayed on between “restarts” started getting shorter and shorter.

Eventually the restarts did not work, but only one beacon stayed dark, the other gave a short flash, every other flash cycle. NOTAMS were becoming a habit, and this was one habit we just were not going to support! Meanwhile, we experienced only one or two problems with the top beacon - and never any issues with the bottom level beacons.

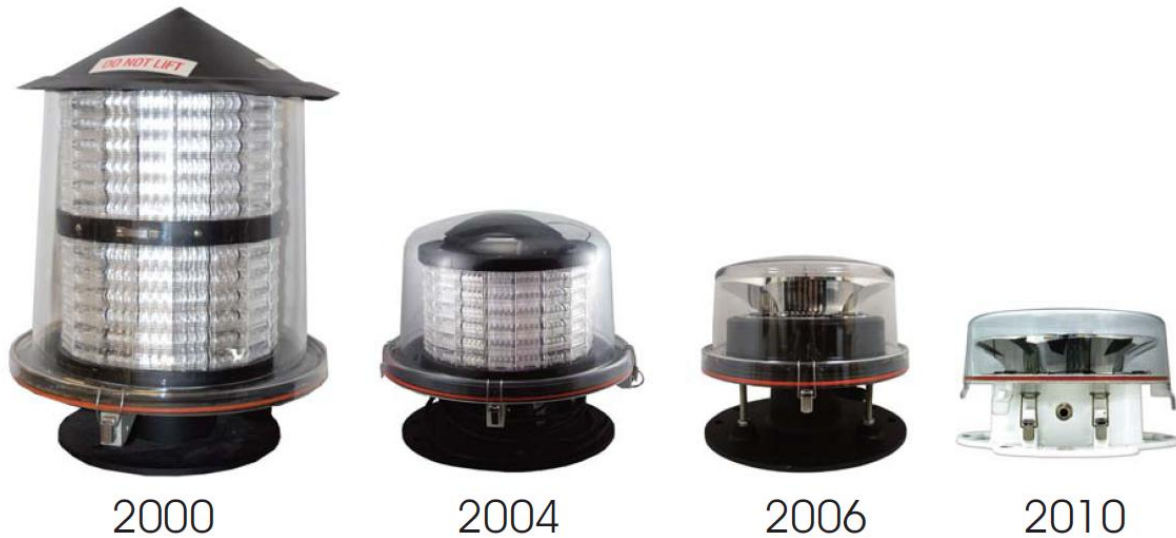
The Orga beacons the Dialight units replaced were brought into our shop and bench checked. Neither beacon showed any problems whatsoever. They were left burning for 48 straight hours without a hitch. Obviously the high RF field was causing the switching power supplies to malfunction.

Al Slater of Slatercom-WCD wrote the following about my situation in particular: “So far I still believe that the RF issue with these lights is that RF is being conducted in the power cable and seriously affecting the switching power supplies these lights use. To that end, my theory is that the capacitors especially are not designed for higher RF fields and may over time degrade to a point where the problems you experienced happen full time.” My thanks to Alan and Mike Slater at Slatercom-WCD for technical information to include in this article and all other help they have given me.

**Dialight LED beacons – the technology definitely has advanced over the years.**

The first night they were in operation it turned very cold, quite windy and moderate snow fell. Nothing like a trial by anti-fire. The new Dialight beacons worked that night, and have worked every night since then.

I cannot say that the latest generation of Dialight LED beacons will work flawlessly in every situation. However, I can speak to my experience with them, and I will continue to recommend them for use in high level RF, FM broadcast situations, like the one I have here.
