The Maintenance Shift **Unexpected Changes – Now What?**

[December 2018] In an era when many transmitter sites are visited infrequently, most good radio engineers pay close attention to operating parameters. When something happens, how one proceeds is important – and how fast. Waiting until there is “smoke” can be very expensive in the end. Clay Freinwald explains.

Bonneville Seattle has two AM stations with transmitters located on Vashon Island in Puget Sound near Seattle. KIRO/710 (50 kW – DA-N) and KTTH/770 (50/5 kW - DA-2) – which is also diplexed with iHeart Media's KFNQ/1090 (50 kW – DA-2).

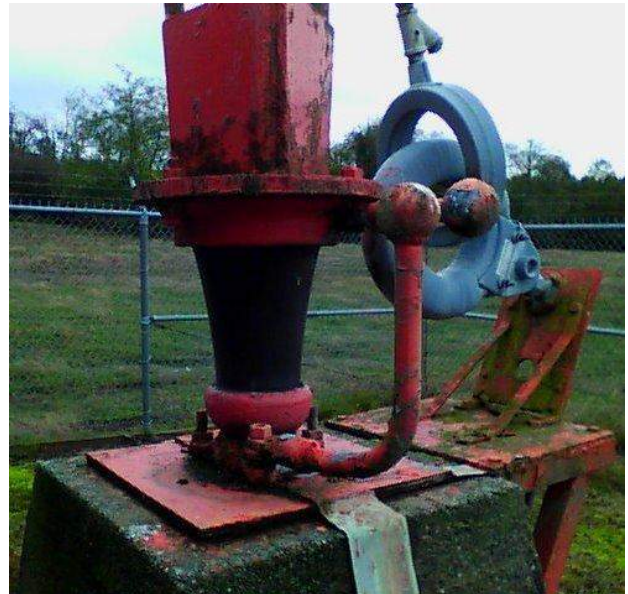
ing the device at the base insulator produced a reading of 150 Degrees!

Shown here is the base insulator of Tower #3:

Now, in Stevens own words, what happened next: *“At the base of the tower above the insulator there is about a one foot well with drain holes on four sides, moss and debris had blocked the drain holes above the insulator. In this well we found a partially decomposed rat and an old bee hive.”*

“On the insulator, there is a stainless steel plate, glued with Mastic material to seal the hole used to access the void in the insulator.”

Upon inspection, it looked like rain water pooled and may have found its way past the mastic material into the void, filling it up. We also found out that condensation can build up in the void if the drain hole is plugged.

Using a wire brush and custom fabricated poker made out of #12 copper wire, they found the drain hole that had been plugged with debris.

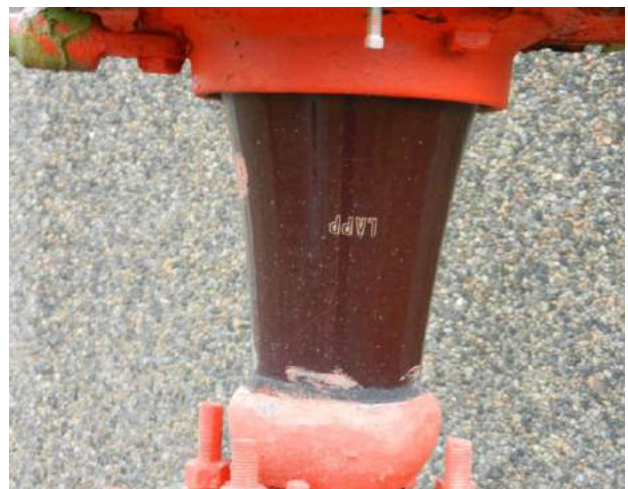
And, here is a closer view”

All looked, on the surface, to be “normal.”

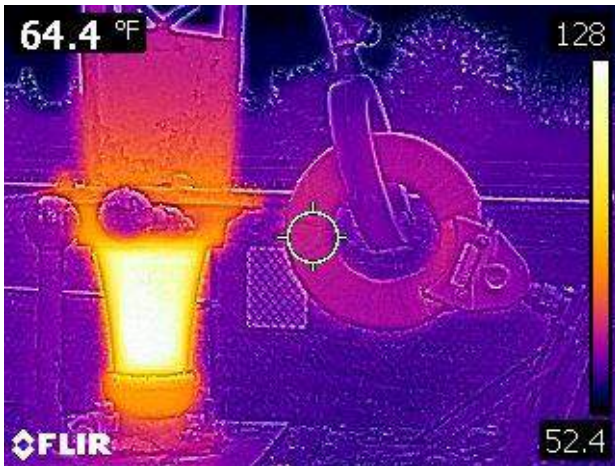
Interestingly, both Bonneville and IHeart now had them, and soon brought them out to the site. The thermal images clearly showed the insulator was getting just a bit warm.

Notice the temperature scale on the right

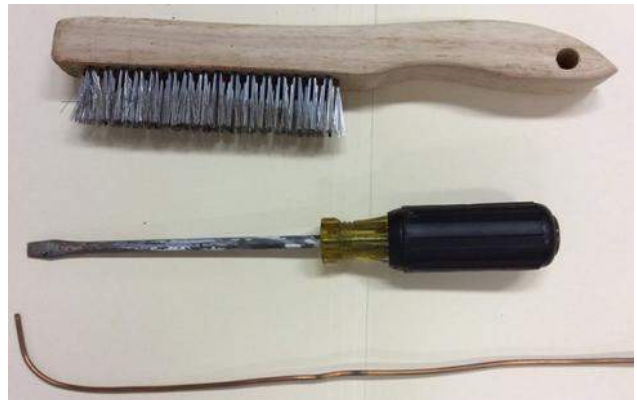
When cleared, the water within the bases insula-

tor drained fairly rapidly. Thankfully, a close inspection of the insulator showed it was not cracked or otherwise mechanically compromised which would have led to more issues
