The
Broadcasters' Desktop Resource

Tech Tips

Death by Capacitor

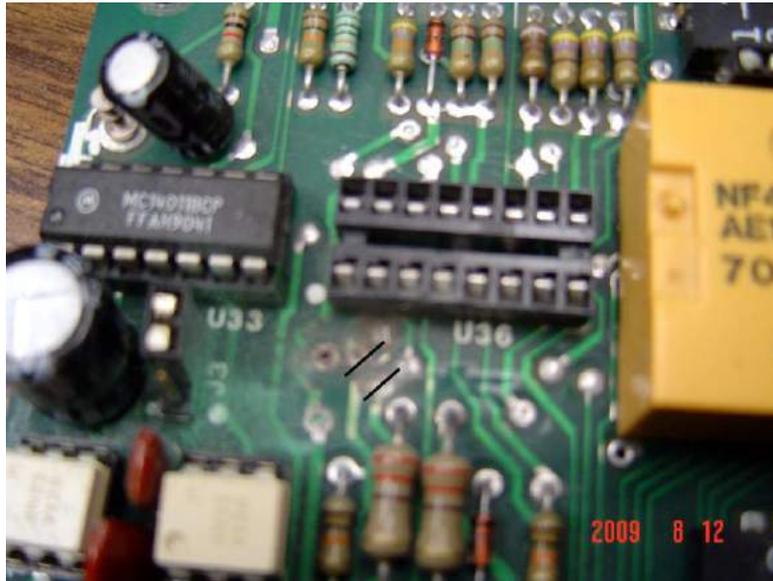
Finally, checking the 100 uF capacitor, I found it measuring only 74 uF. A closer inspection showed the capacitor had spilled its contents and eaten away a trace on PC board.

This trace was connected to the mute signal to stop Day/Night adjust switch selection. In fact, the trace was eaten completely open! This is a case where the capacitor's chemical leakage actually ate away the foil path. Failure was from the chemical action; the picture shows the damage.

Solving the problem entailed cleaning the pc board and replaced the missing trace for mute disable. It appears the 2004 IC was damaged, but the affect is to status LED and did not affect the relay switch.

The lesson learned is electrolytic capacitors need to be changed out after ten service years - and must be done at 15 years even if the gear still appears to be working. The danger is not just the loss of component value but the goo oozing out from bad capacitors. For this unit it is clearly time to blitz all the capacitors
