The  
**Broadcasters' Desktop Resource**

### **The Dangers of Leaving "Well Enough" Alone**

*[August 2009] Contrary to bean counter logic, solid state does not mean "no maintenance required." Stations that want reliable service, even from some of the best-designed gear need to pay attention to continual, regular maintenance – from air filters to electrolytics. Warren Shulz is one who strongly believes in trying to stay ahead of potential component deterioration. Nevertheless, from time to time, a surprise happens. Warren takes it as a learning experience.*

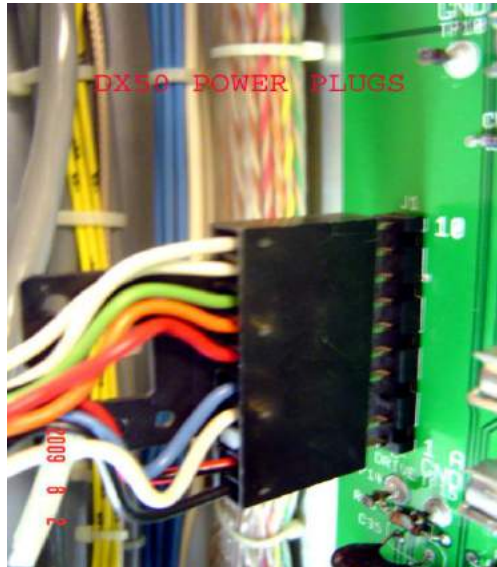
Following the circuit path, I moved connector J6 (on the DC regulator) and the B side voltage quickly changed back to a normal reading, stabilizing at 4.72 VDC.

It seemed apparent that the issue was related to the connector, although these tin plate connectors have large surfaces and you would never think of them being erratic. Good contact is important: these bias voltage-level tests are critical shutdown points if the FET power PA amplifier bias is not correct. Their purpose is to protect the 1,024 FET devices from failure - as in *all of them could be destroyed!* - because of a bias fault.

**The plug would have benefitted from a bit of exercise over the years**

Basically, I suspect the connection became erratic over time and the comparator simply switched off. This was a good find and should be a warning that connectors that have not been moved for years can become a source of intermittent faults. I would suggest making it a part of the yearly maintenance plan.

The repair process was simple. I cleaned all the tin plate connectors in the front of the PA modules, wiping them with gold wipe chemical cloth, and then treating them with DeoxIT D100L by Caig - a contact lubricant and preserver. Afterward, it was clear that the connectors moved on-off with less friction than before. (Other ribbon connectors in the DX-50 are gold on gold and would be more stable.)
