The 'ole Comtech Dish Just Ain't What She Used To Be

By Alan Alsobrook

[August 2011] There are not very many stations today without at least one satellite dish for programming. Perhaps yours went in years ago and has worked well. Alan Alsobrook wants to alert you to a potential problem, so you will be ready if it happens.

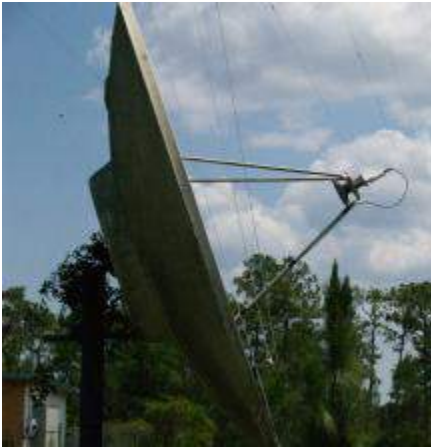
What happens is that the material used in the plate has been attacked by Ultra Violet light over the years and, eventually, it just starts falling apart. If you have not checked your mount regularly, your first warning is likely to be loss of signal on all satellite receivers connected to that dish. If that happens to be your only dish, it is not going to be a good day.

A visual inspection quickly confirmed the problem, when I saw the feed horn pointing below the center of the dish.

The feed horn is askew in relation to the dish

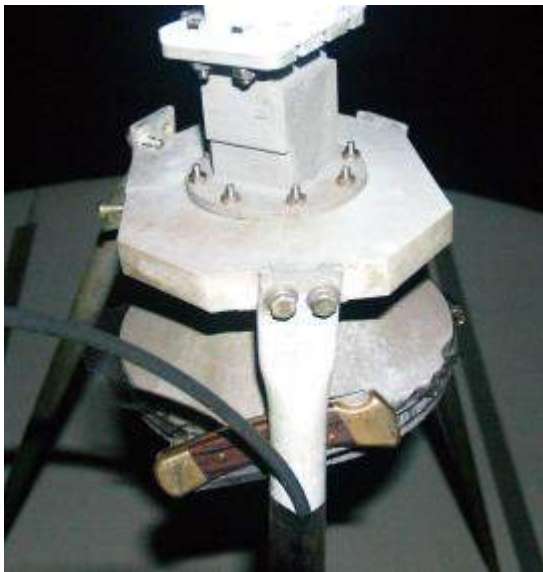
Temporary measures got the signal back

Careful placement of my trusty old Buck knife was able to restore a missing program feed until I could make more permanent repairs.

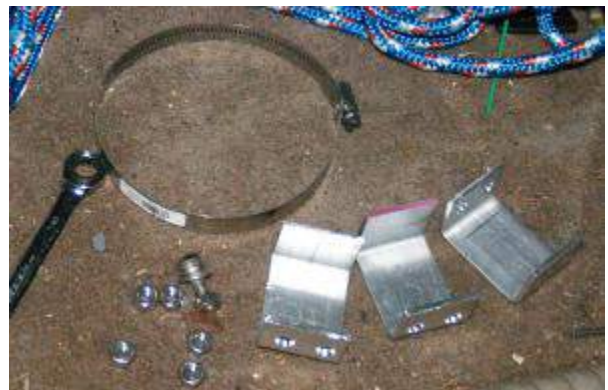
The repair parts on the bench, at slightly less than \$1000

- a strip of 1/8-inch x 1 1/4-inch flat aluminum stock,
- a 4-inch diameter stainless worm gear clamp,
- and six 1/4-inch-20 stainless 3/4-inch nuts
- various bolts and cut washers.

First I cut out three 4-inch long sections and made two 90-degree bends, 1-inch from each end giving a C shape. I then predrilled one end of each of the three straps centering two holes 3/4-inch apart to match the existing holes in the feed arms.

One thing I will remember for the next dish repair I do is to make a 1/2-inch wide notch on each side of the C piece, where it mates with the feed horn. I would do that by cutting two slots about 1/4-inch deep, and bending the tap towards the feed horn about 30°. This would give a place for the stainless steel strap to sit and lock the feed horn in place better.

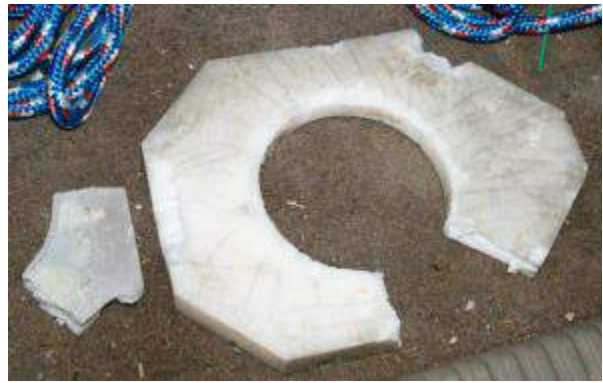
After a bit effort I was finally able to break out a section and remove the feed horn. A hack saw would likely make the job much easier. Once I got the feed horn on the bench and disassembled everything, the problem with the broken mounting plate was obvious.

This mounting plate was not going to be of much use

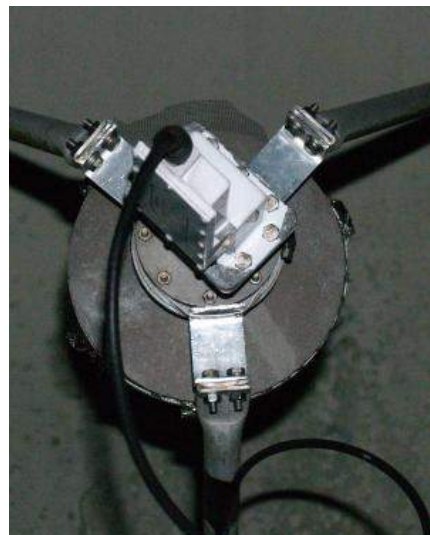
After getting the feed horn back in place, it is probably be a good idea to tweak up the LNB, and dish. You might note in the following picture that I somehow decided I would reinstall the LNB 90° off axis.

That does not work vary well. So let me repeat the part about taking a picture *before* you start. (I did not look at my pre-repair picture until after it did not work, oops!)

By the way, before you try this yourself: if your feed horn is still in place it would be a very good idea to take a picture of the feed horn positioning, or at least make a careful note as to the polarization positioning of the LNA.
