Broadcasters' Desktop Resource

The Worst I've Ever Seen!

Part A into Part B - Interesting Fits

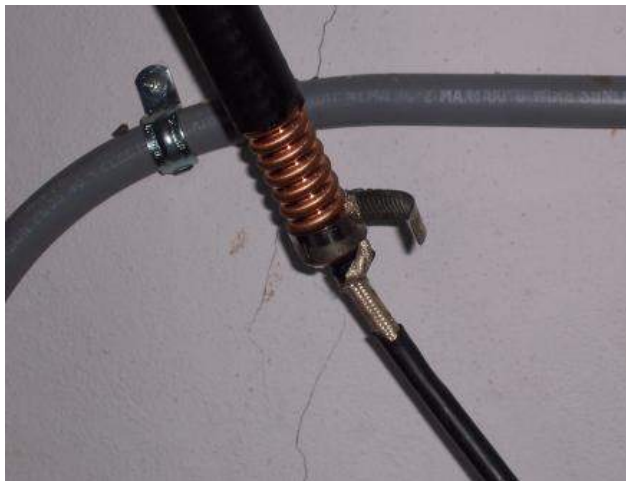
Terry Cowan saw the original picture, and sent this one to share. "I took this picture several years ago in the Caribbean," he writes. "The station was a Class A and, at the time, was running around 300 W TPO."

"Surprisingly, VSWR was low."

One can only look at this and, if not admire the mating of these two types of coax, at least respect that the guy probably had no Radio Shack nearby.

And the hose clamp did provide for a reasonably stable ground connection.

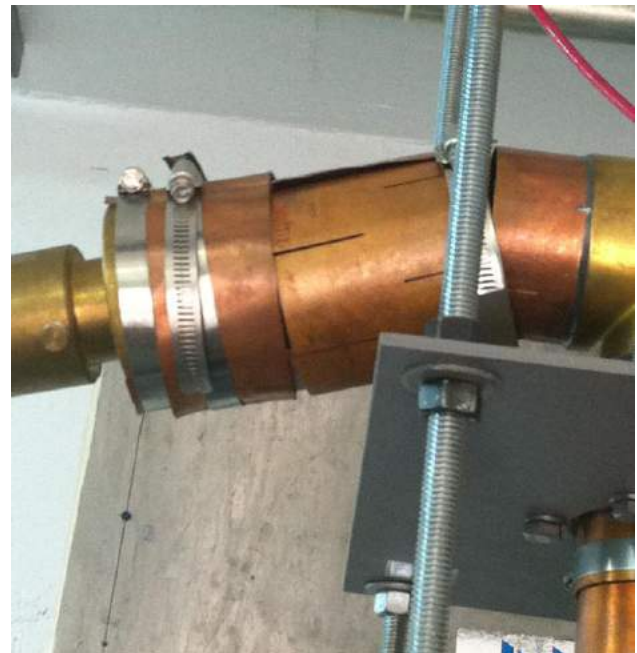
The main transmitter was off the air, as was the auxiliary transmitter. When Bowman arrived, a Crown 150 translator had been "fitted" to the feed line to put a signal on the air.

At first look, Bowman was stunned at the connection.

The transmitter was connected to the rigid line via a series of bullets, reducers, adapters, and covers. It was almost worthy of a Rube Goldberg award.

But again, just as with the one Cowan saw, in the end, Bowman had to acknowledge the local guy had actually done a good job in getting the RF to the antenna. The station was on the air!

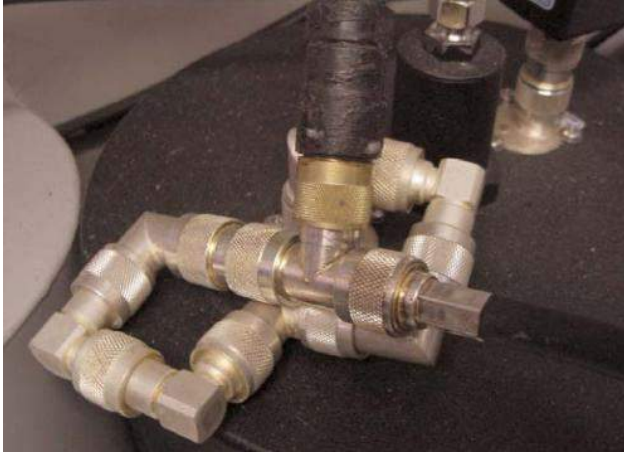
The picture was taken at a mountaintop transmitter site where several two-way antennas were in close proximity and, according to the engineer, the feed line shown needed some attenuation.

Since each connector will cause a small insertion loss, it is possibly understandable that the engineer felt he had to use every connector in his toolbox to bring the RF down.

But it also seems the concept sort of got away from him – it is a bit puzzling that he never got rid of the connectors and installed a proper RF attenuator.
