Broadcasters' Desktop Resource

What's Wrong with This Picture? **Antenna Mounting 101**

Pictured here is a fairly recent FM installation in a rural area. It is a non-directional antenna, running under 900 Watts TPO.

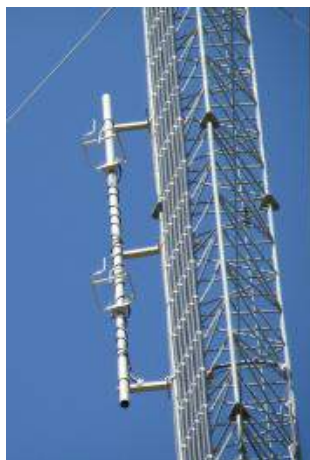
This picture was taken from the East side of the transmission site.

The antenna is mounted on the leg facing to the Southwest.

But, would it help to note that the City of License is about a half-dozen miles to the East?

And that the signal is not as good there as one might hope?

Or that the main highway to the North has almost no signal at all?

The reader who sent this is works for a company that recently purchased the station. Yes, we can assume that plans are already in progress to re-mount the antenna.
