# Broadcasters' Desktop Resource

### FM Antenna Systems Maintenance: Preventing Signs of Impending End of Life Part 2

**By Tom Silliman**

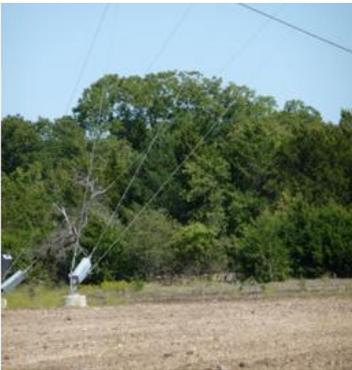
The snubber has rigid anchors on either side of the wire and has wires attached to shock absorbers that go up to the wire where a pulley is installed on the wire.

The pulley can ride up and down the wire tied to the shock absorbers. Then if the wires try to gallop, the snubber wheel subdues the movement and the shock absorber absorbs the energy. In the end, the tower it is much more stable.

I strongly recommend this for areas with wind and ice or if your tower is over a thousand feet tall. It will increase the life of your tower and all the appurtenances.

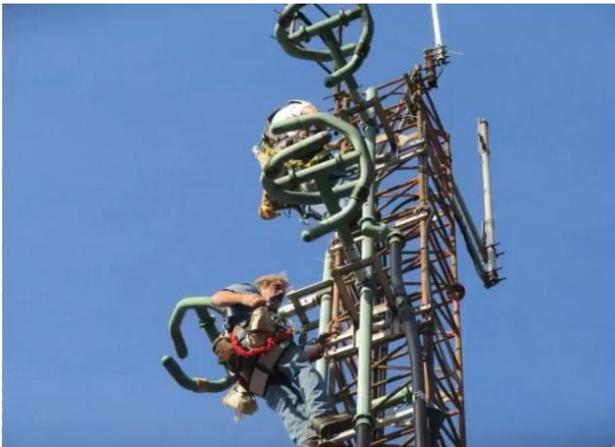
**An ERI crew at work inspecting and replacing insulators**

This was an example of where we reported that insulators were starting to deteriorate due to solar exposure after 25 years. When we climbed the tower, we could see where the insulators were leaking and where the resin had deteriorated due to exposure to the sun. The outer layer of fiberglass was loose without the fiber glass resin.

We removed the worn out insulators, replacing them with new insulators manufactured with plastic rather than with fiberglass.

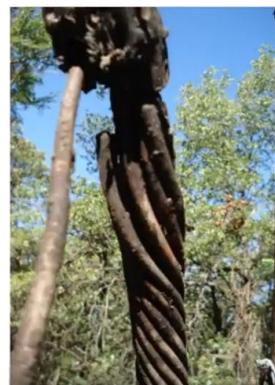
The inspection should include inspecting the guy wires for wire deterioration and the tower legs for leg steel deterioration. Unfortunately, most FM Broadcast tower owners do not schedule such periodic tower and antenna inspections.

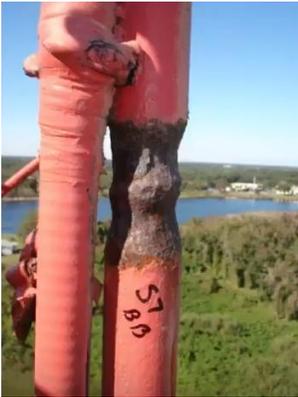
Here is an example of a tower leg in Florida where salt air has resulted in a guy wire failure. We repaired this after an inspection discovered the problem.

Another example of salt air causing tower deterioration is shown here. Here, a tower leg was rusting where the metal clamps were installed to hold a cable to the tower leg.

It is a tower leg necking that actually can be repaired, but you have got to put on external clamping that probably should be welded.
