THE WORST I'VE EVER SEEN

The Tower Leg that Just "Melted"

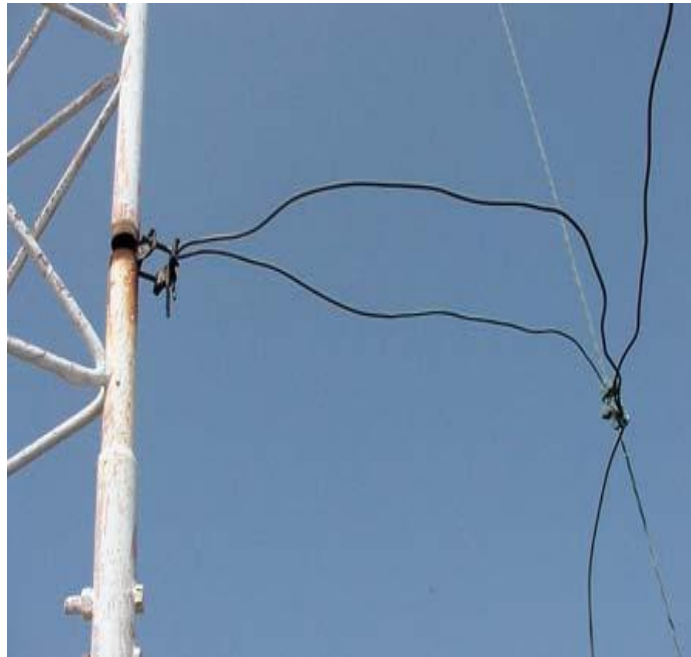
As Barber's workers approached the 250-foot level, they were somewhat startled at to see a situation that you could only describe as "hard to believe."

One of those truly "it is hard to believe your eyes" situations

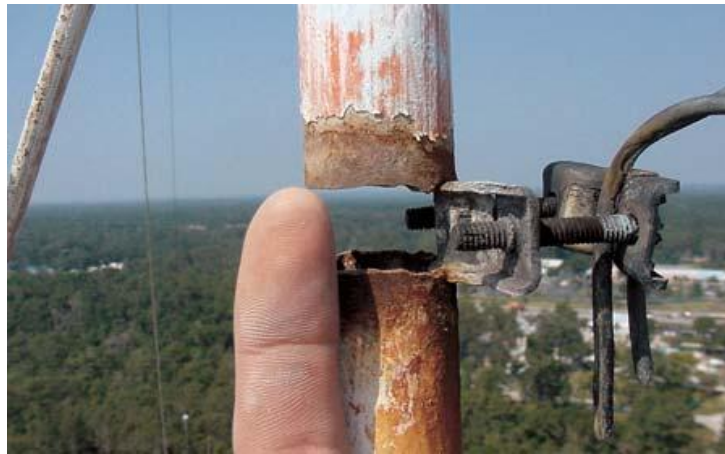
As the climber got closer, the view was even less appetizing. It was what he thought he saw – a rather nasty gap in the leg.

This tower leg was not designed to have a window

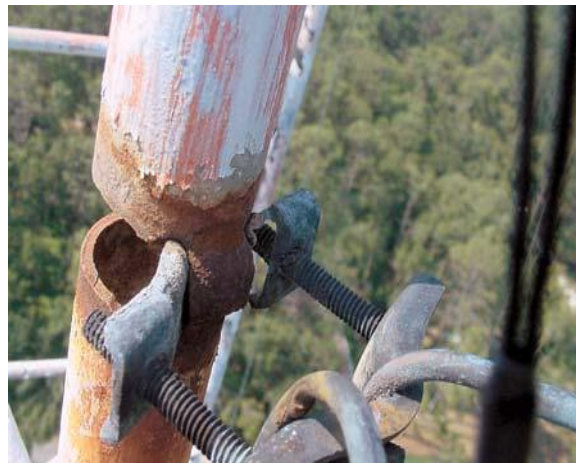
As you can see from the condition of the tower and paint, over a long time, something “ate away” the metal. Obviously, the electro-chemical reaction, aided by the pull of the unipole supporting wires did a good imitation of a hot knife going through butter – or the Wicked Witch of the East. And, by the point where these pictures were taken, only the bracket itself was holding the tower leg in place.

Only a tiny, buckled bit of the tower remained

It was only a small gap, obviously hard to see from ground level. But it would have been more than large enough to bring the whole tower down if any stress from high winds, for example, had occurred. Barber relates that the climber stopped what he was doing and got off the tower immediately. Plans to repair the tower were carried out shortly thereafter, and at last report, the structure was stable.
