# ***Broadcasters' Desktop Resource***

## **The Worst I've Ever Seen!** **When Getting Back On The Air** **Trumps Neatness**

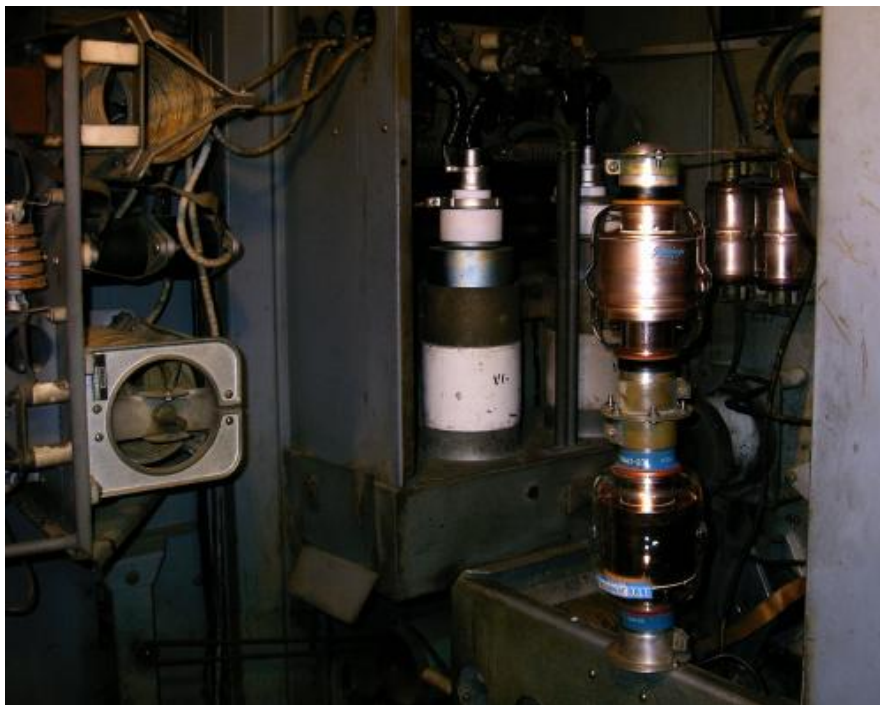
You are looking inside the back of a vintage BC-10B transmitter, in a small market station. The plate overload was tripping, taking the station off the air.

The engineer tracked the problem down to a bad 500 pf, 30 kV vacuum capacitor. But, given the age of the transmitter and the difficulty of finding a re-placement – not to mention that even a used capacitor sells for \$1400, plus tax, shipping and hand-ling – getting back on the air quickly presented a problem.

The solution chosen by the engineer might seem to be “The Worst” but really, when balancing costs and time, this temporary solution might not be considered so bad. He reached out to various spare parts bins and found a pair of 1000 pf capacitors. Together they made 500 pf, and the transmitter was back on.

Dubbed the “Tower of Babel,” and hanging out the back of the PA compartment, nevertheless it stopped the loss of airtime.

Purists might recoil at this image of two 1000 pf capacitors stacked in such way, but again, the goal was to get back on the air – and that is exactly what was accomplished.

One thing is for sure, the owner of this station should be scrambling to find a way to replace this BC-10B. In this current economy, that is not always easy, but as more and more stations look at the costs of running (electrical) and repairing these older transmitters, the better a new one might look on the budget.
