## **The Worst I've Ever Seen!** **Is it a Generator Battery or an IED?**

*[May 2011] Broadcasters depend upon generators to come on line and pick up the slack when the local utility power goes out. Careful maintenance is essential. Not only do you need to make sure a generator is ready when needed, but you need to avoid personal injury.*

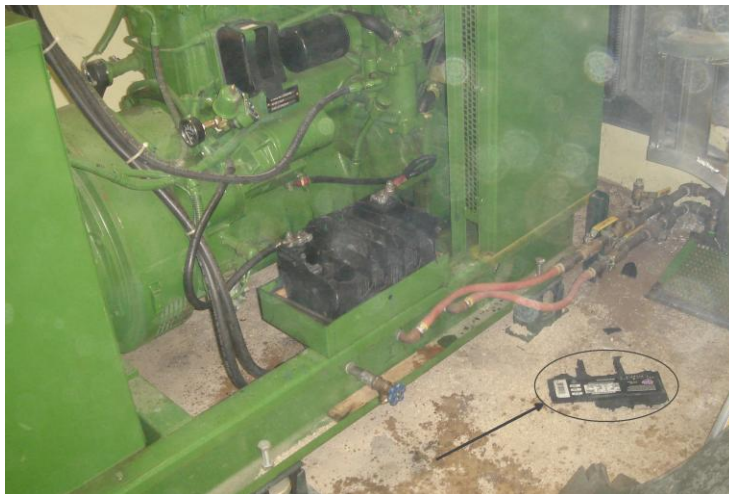
Terry Baun shares this picture, from a generator at a TV station in Wisconsin. He notes that this picture was taken following a routine start-up of one of their generators.

Baun was happy to report that no one was injured when this battery failed. (You can see the top was blown off and is laying on the ground in pieces – the cells are exposed.)

Generally a battery explosion results from ignition of the hydrogen/oxygen gasses created by the charging process. This is normally vented to the atmosphere, but some residual gas can remain in the battery.

Baun theorizes that something internal to the battery supplied a spark, possibly a cell that shorted when the battery was called upon to produce the starting current for the generator.

This was a sealed battery, so there was no way to check for low electrolyte level, which is another possible cause for a spark. As with many generator batteries, this one was on a constant trickle charge because it supplies power for the transfer switch.

In any case, Baun will be replacing this with a non-sealed battery.
