The Worst I've Ever Seen!

Dishing Out Some Unwelcome Visitors

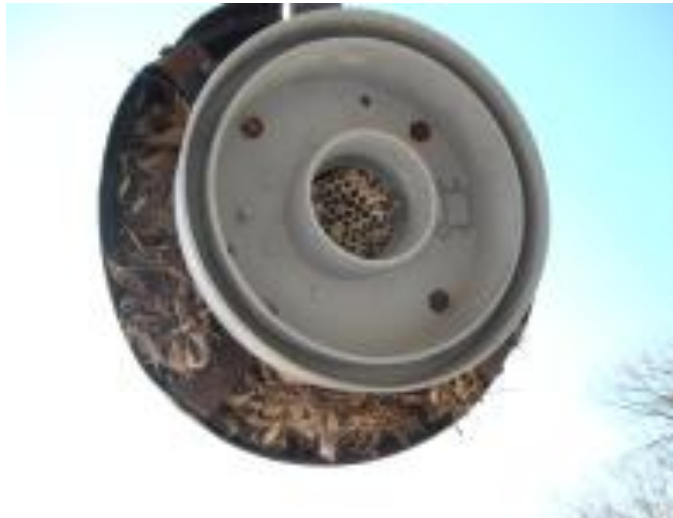
The feed horn has some visitors

Obviously, a wasp nest in the feed horn was not a good sign! A large wasp nest was even more troubling. At that point, the question arose, as Barnes put it, "How long have they been having reception problems?" But, then when he removing the cover, it definitely revealed more than he wanted to see.

This time, fortunately, the nest in the feed horn appeared to be pretty inactive. Barnes used the hooked end of an electrician’s 12-foot “glow stick” to pull the nest from the feed horn. He notes: “I rarely spray. I haven’t been stung in years. The wasps don’t bother me all that much. Yellow jackets, on the other hand, are a completely different story.”

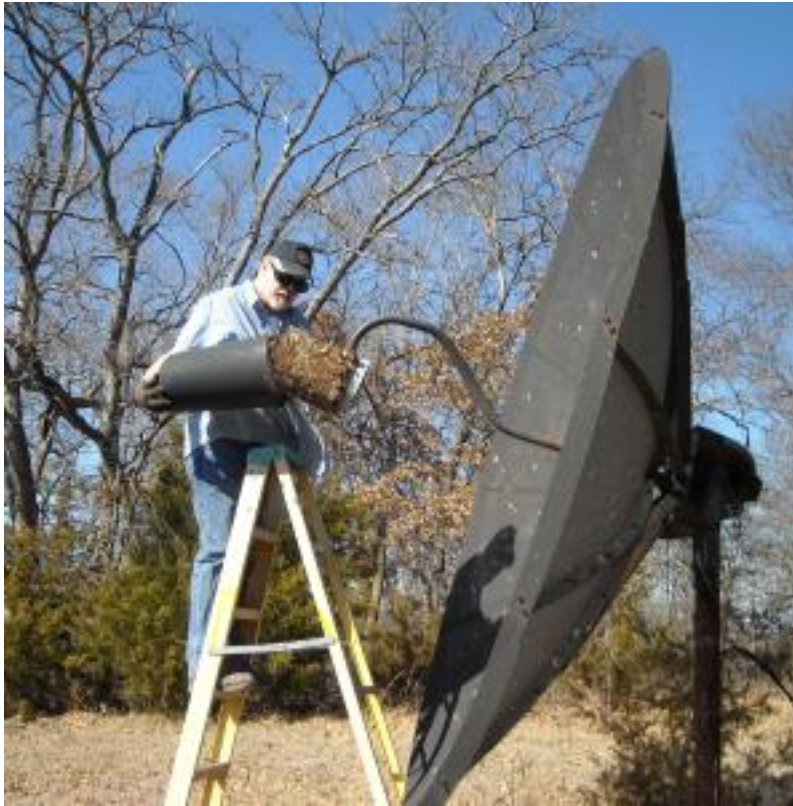
It was a full house

Barnes said, “I had no clue what I was going to find under the radome. Usually, I just pull it off. If anything comes swarming out, I can move surprisingly fast for an old fat guy.”

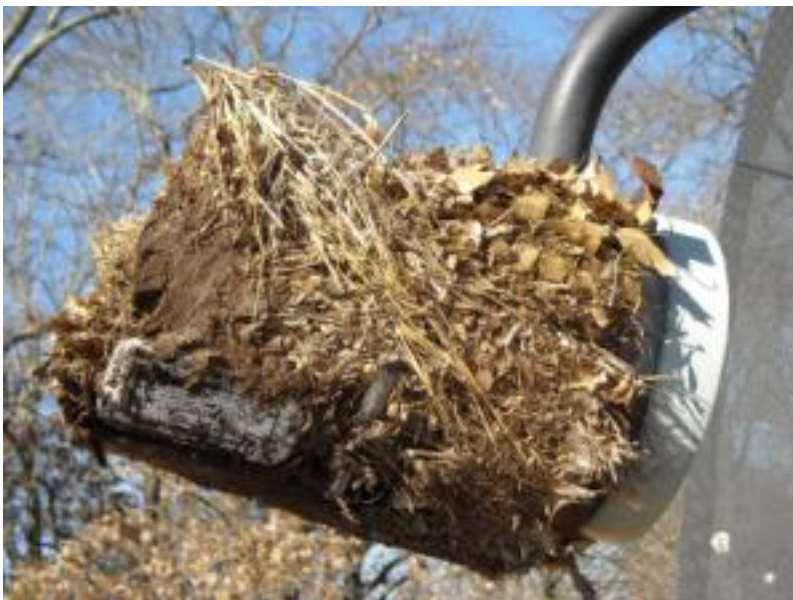
This close-up picture just sort of tells the whole story.

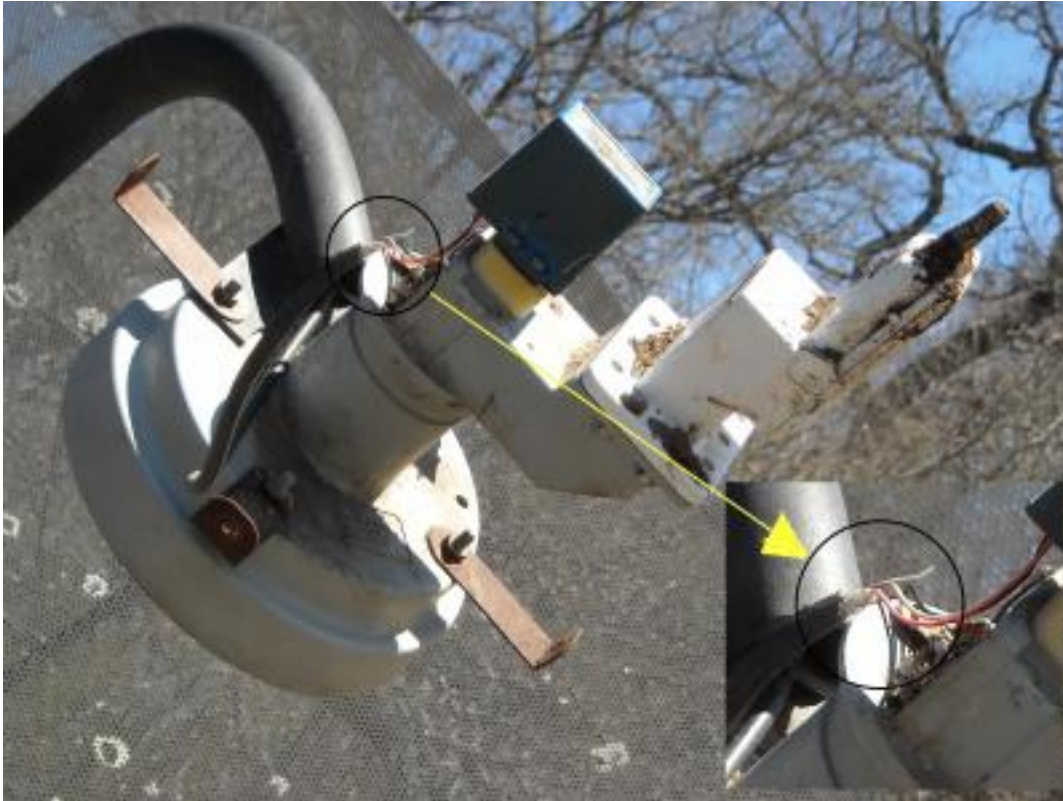
The coax had come loose from the connector

It was clearly a coax issue, with all the pressure inside the cover causing the coax to become loosened from the connector. A new connector was placed on the coax and as Barnes described it: "... all was well with the world."
