The  
***Broadcasters' Desktop Resource***

## **The Worst I've Ever Seen!**

### **Dishing Out Some Unwelcome Visitors**

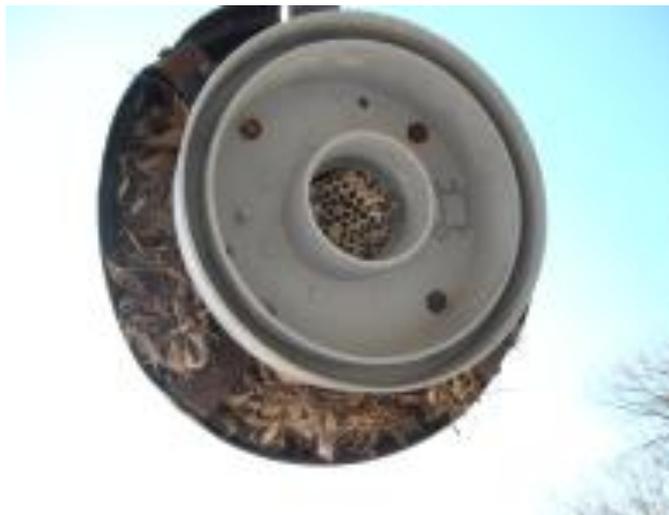
**The feed horn has some visitors**

Obviously, a wasp nest in the feed horn was not a good sign! A large wasp nest was even more troubling. At that point, the question arose, as Barnes put it, "How long have they been having reception problems?" But, then when he removing the cover, it definitely revealed more than he wanted to see.

This time, fortunately, the nest in the feed horn appeared to be pretty inactive. Barnes used the hooked end of an electrician’s 12-foot “glow stick” to pull the nest from the feed horn. He notes: “I rarely spray. I haven’t been stung in years. The wasps don’t bother me all that much. Yellow jackets, on the other hand, are a completely different story.”

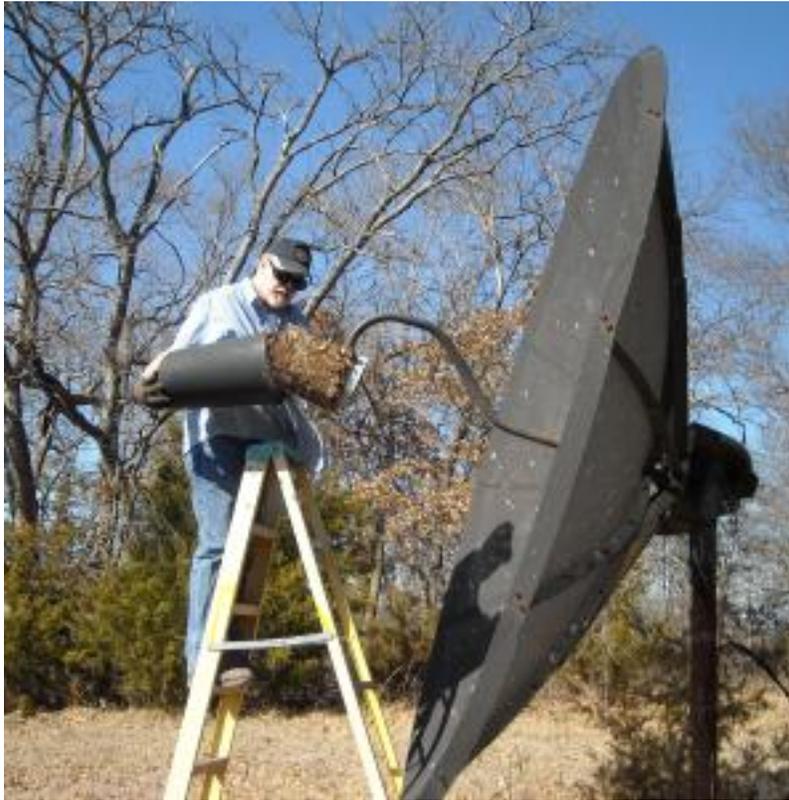
**It was a full house**

Barnes said, “I had no clue what I was going to find under the radome. Usually, I just pull it off. If anything comes swarming out, I can move surprisingly fast for an old fat guy.”

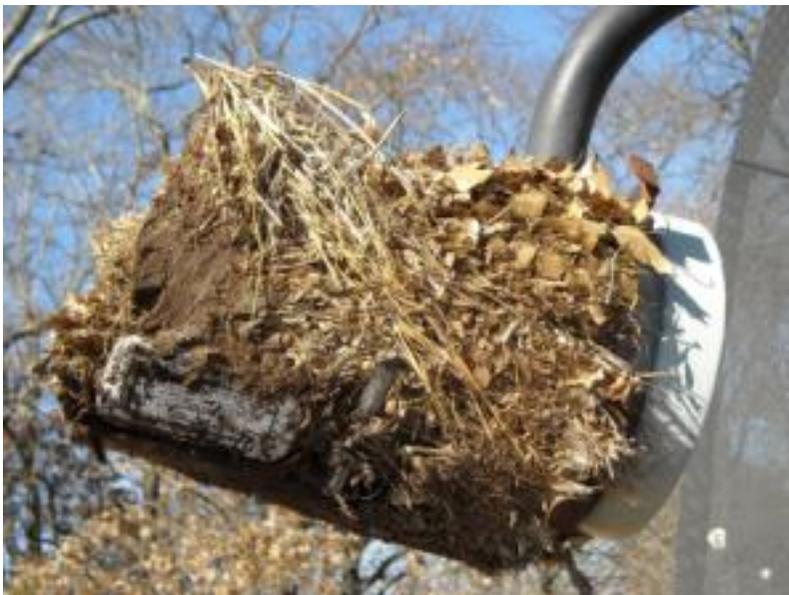
This close-up picture just sort of tells the whole story.

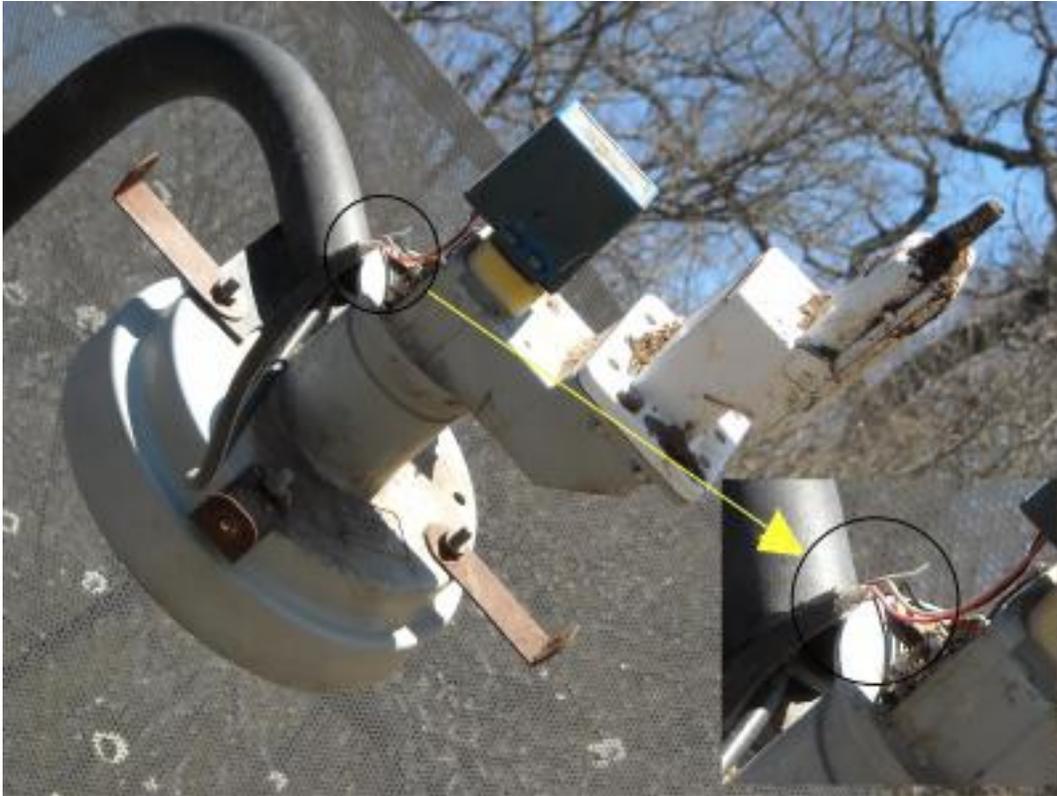
**The coax had come loose from the connector**

It was clearly a coax issue, with all the pressure inside the cover causing the coax to become loosened from the connector. A new connector was placed on the coax and as Barnes described it: “... all was well with the world.”
