# **Broadcasters' Desktop Resource**

## **The Worst I've Ever Seen!**

### **How Not to Bond Copper Strap**

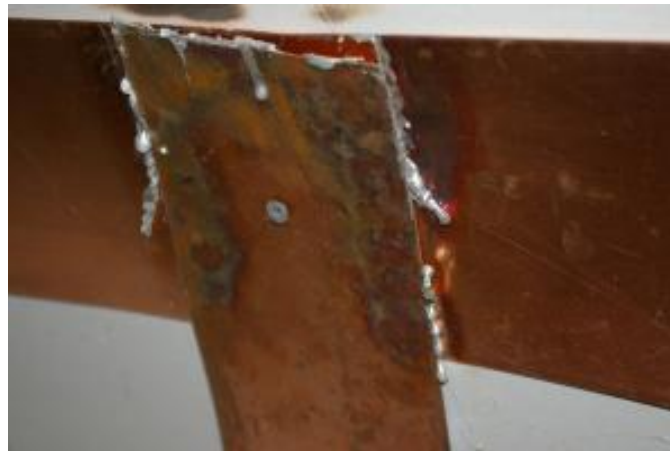
**This is an ex-ground**

He reports: “I have to wonder just what were they thinking? I found a station here with the four-inch ground straps soft-soldered to each other – sort of. I think they actually used a 40 Watt soldering iron to melt the solder *onto* the copper. I peeled it off with fingers/pliers.”

Shortly after taking this picture, the connection was redone properly with silver solder.
