Broadcasters' Desktop Resource

The Worst I've Ever Seen! **A Towering ... Tower?**

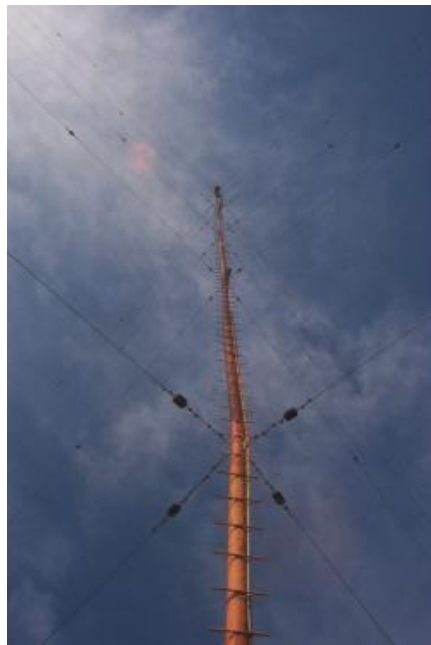
**It does not take a surveyor's transit
to determine this stick is not quite plumb.**

Getting closer to the structure, Rother understood why it looked as it did. “The “tower” appears to be made of six 30-foot oil drilling shafts that have been welded together, and foot pegs welded on for climbing.”

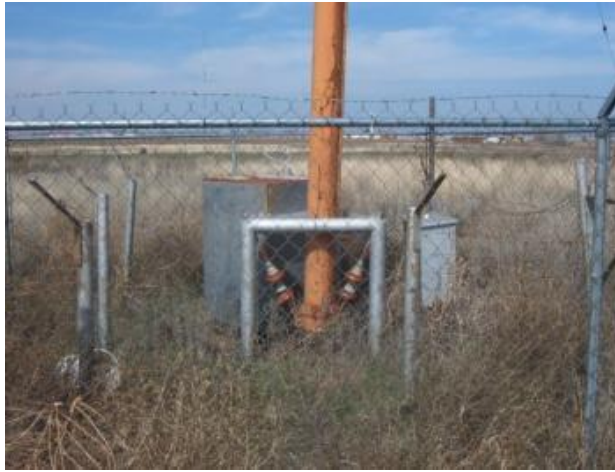
He continues: “The “tower” is guyed from four sides instead of three, with the guy levels appearing to be at each joint in the drill shafts. The base of the “tower” is suspended by what appears to be high tension power line insulators mounted from the “tower” to a triangular mount that has legs that go into the ground.

**Perhaps this is not a typical tower installation.
The ground, by the way, is level, the tower is not.**

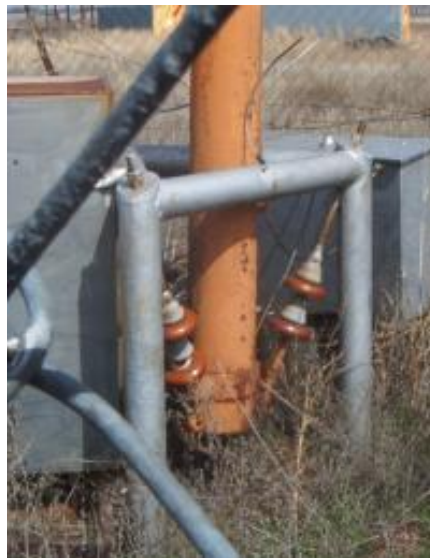
“The base of the "tower" is suspended in such a way that there is nothing but earth and grass directly below the "tower" itself. The "tower" appears to have once been lit, but when I saw it, it had no electrical power crossing the base insulator.”

**Apparently, this tower was supposed to be
suspended with nothing under it at all.**
