# ***Broadcasters' Desktop Resource***

## **Tech Tips**

### **Replacing Hard-to-Fit Electrolytics in Video Monitors (...or anywhere)**

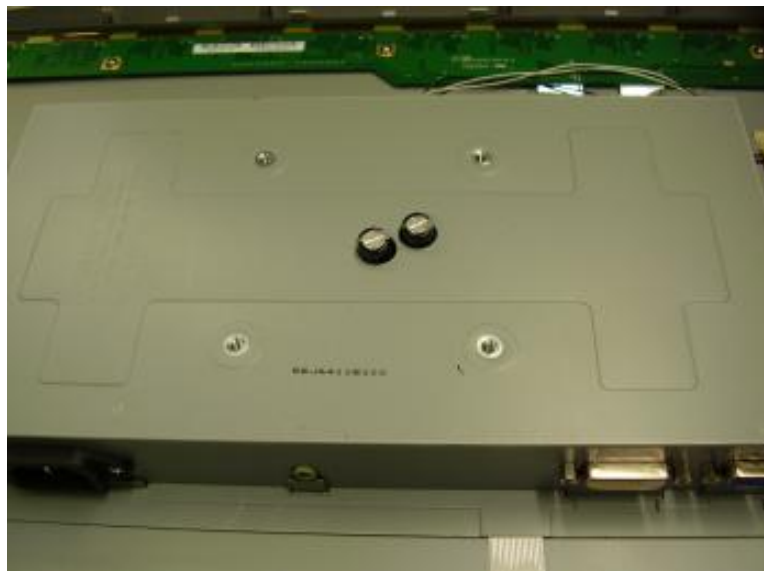
Unfortunately two of the capacitors were too tall to fit under the cover, as there was no room on the board to lay them down. Unwilling to just give up and buy a new monitor, I took a unibit and punched holes in the chassis to allow room for the tops of the cans.

**All too often a replacement part will not fit perfectly.  
A well-placed hole in the case solves the problem.**

We had an off-brand flat-screen monitor in our station that quit working after blowing five electrolytics. After inspection of the motherboard, it was clear the manufacturer did not use ones that were of low enough impedance - so I ordered some replacements that were of the appropriate value.

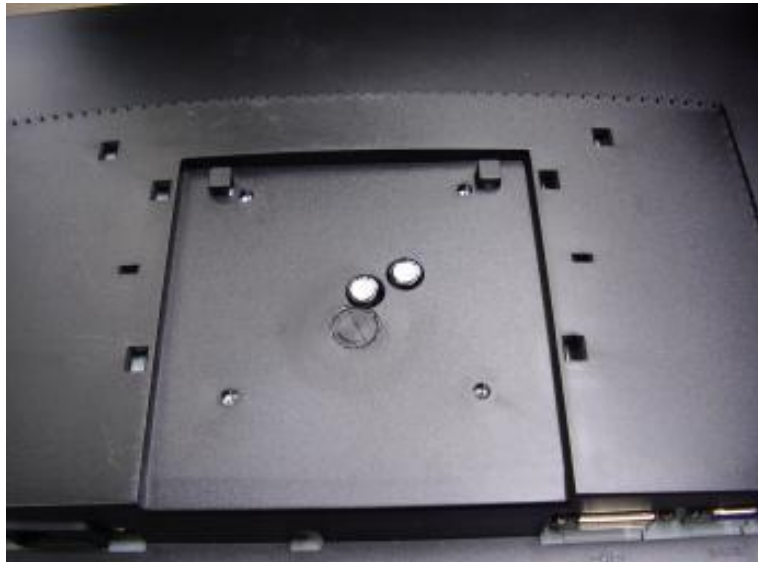
As is common with most all consumer electronics, space is always at a premium. So, even with the holes made in the motherboard case, there still was the problem of fitting the electrolytics inside the plastic back of the monitor itself.

Another set of carefully placed holes in the back of the monitor provided the way to solve the problem completely.

**Another set of holes, and it all fits together.**

As shown in the picture, everything fit back together quite nicely – and the monitor was working well once again.
