... edited by Barry Mishkind – the Eclectic Engineer

The Maintenance Shift When VSWR is Not VSWR

By Burt Weiner

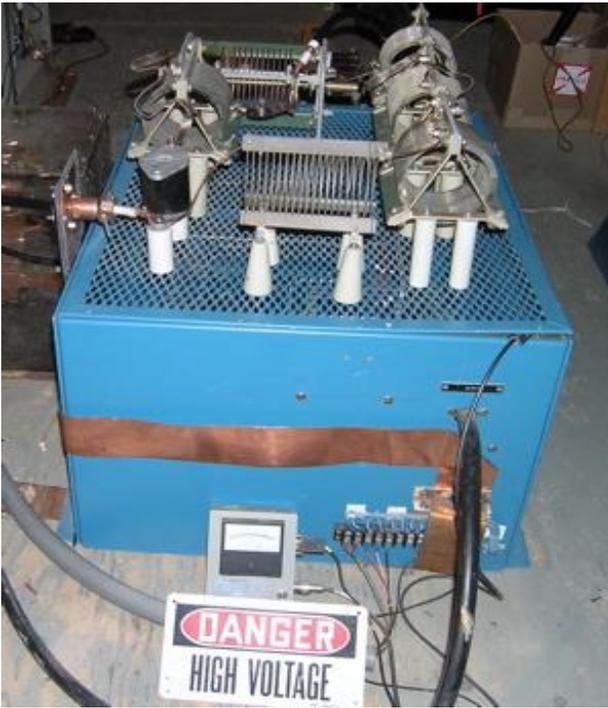
A working kludge

In the picture, all but one of the coils were in series to get the low frequency notch. The filter consisted of a series resonant L/C for the pass and an inductor paralleling the series pass branch to obtain the lower frequency side, notch.

Foraging through the station's "junk" I found enough parts to cobble together a band-pass / band-reject filter to insert between the Common Point input and the transmitter.

This filter was transparent at the station’s operating frequency and completely solved the problem. The station was “up” and running at full power with no indicated VSWR.
