Broadcasters' Desktop Resource

High Powered History Growing Tower Farms in M/SP Part 4 – Finishing Touches and On the Air!

[November 2015] We bring our look at the Minneapolis-St. Paul Telefarm and Shoreview sites to a conclusion as Steve Brown shares the rest of the story of how these sites developed.

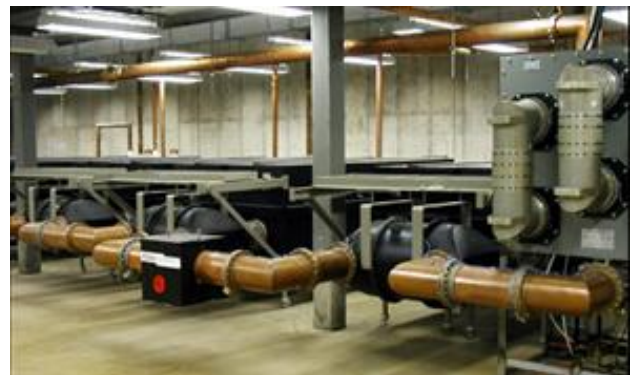
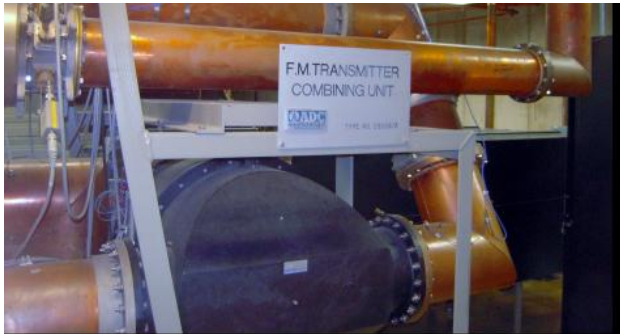
After the dummy loads were repaired, the technician from Britain that Alan Dick sent to tune up the combiner wound up spending most of the winter getting things adjusted.

Unfortunately, what we found was the combiner parameter measurements taken when the system of the s cold would drift as real transmitter power was applied to the modules.

Part of this was problem due to our specification that the combiner system have very good phase response across each station pass-band (group delay) as well as amplitude response. We also required that station-to-station isolation through the system did not rely on any turnaround loss in the transmitters, since no transmitter manufacturer had specified that parameter at that point.

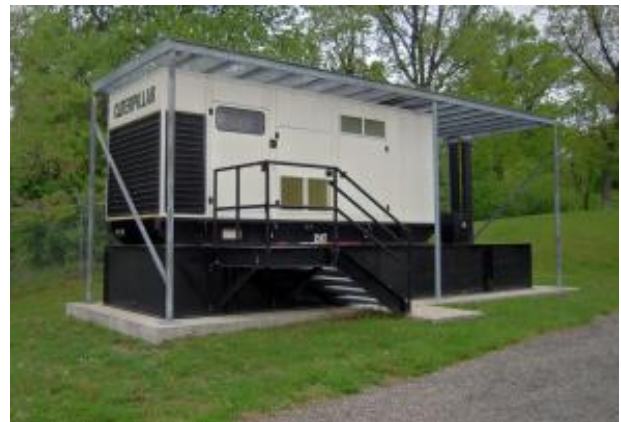
Additions: In 1997 station #9, then WXPT-FM, 104.1 MHz was added to the combiner string. And, as we had preplanned for emergency power, during 2006 a 1 Megawatt generator with lots of fuel capacity and transfer switches was added to the site.

The 1 Megawatt generator, ready for action

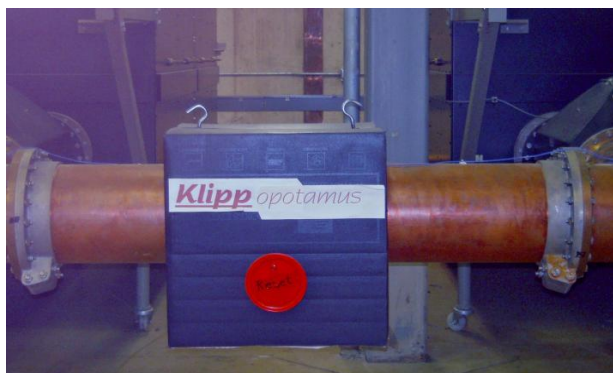
Intrigued by Bill’s imagination, we decided to go a giant step beyond the diodes and create a passive audio clipper that worked in the RF domain. We set the “Klippo” up to process *all* of the stations by clamping it to a section of 9-inch rigid transmission line, supposedly making the playing field really even for all stations.

The World Famous Klippopotamus on guard

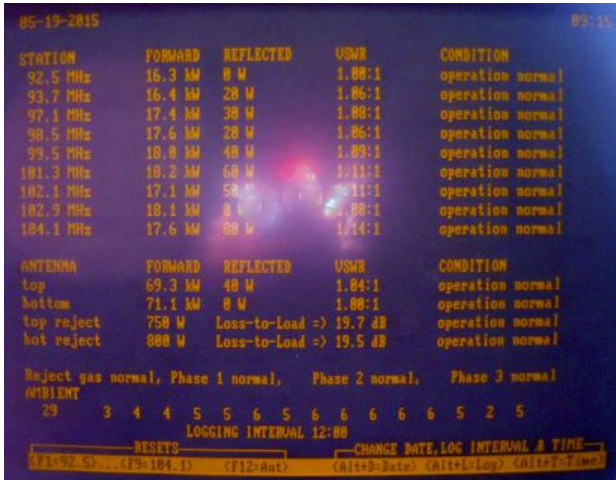
23.5 years after installation the monitor still works!
