FM Antenna Systems Maintenance: Preventing Signs of Impending End of Life

By Tom Silliman

[September 2018] How can you tell if your tower or antenna needs maintenance? A good start would be a presentation from an antenna manufacturer on how to tell if your antenna needs repair or replacing – and how to do it.

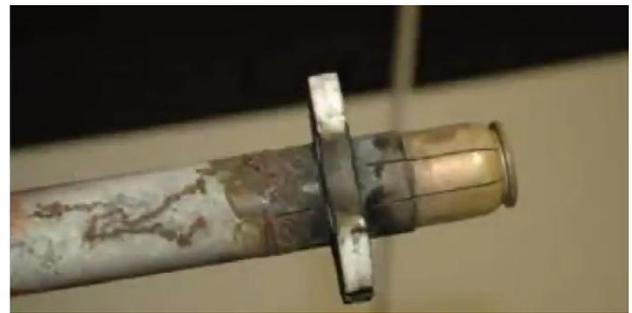
When we turned it off and opened the input connection to the antenna, I found that the input bullet was all yellow and ready to totally fail.

This is what the bullet looked like. We replaced the bullet, cleaned up the outer conductor, placed the inner conductor back, put it all back together – and the noise problem stopped.

The problem would have been found earlier with routine maintenance of that antenna but, in fairness, I did find it before it created a system failure.

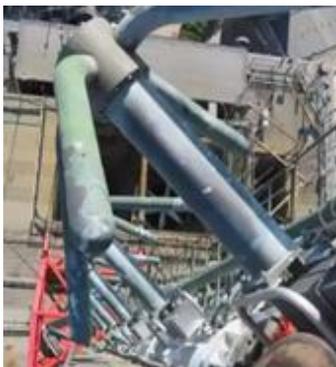
The antenna had an internal pressurized feed enclosed in a fiberglass insulator. The insulators in the antenna elements had deteriorated from exposure to the sun.

You even can see where the resin in the fiberglass insulators had been eaten out – and you could actually see loose layers of fiberglass blowing in the wind.

In this case, rather than painting the insulators, we recommended a rebuild. We brought the antenna down one arm at a time and took them all apart. We replaced all the insulators, put it back up, and now it is ready for another 25 years of service.

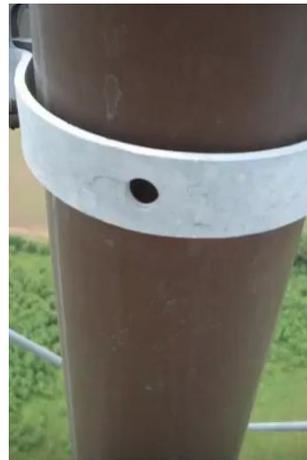
Here is a shot of a transmission line that actually runs through the aperture of the bays of an active side-mount FM antenna. You can see it is missing one of the little insulating buttons that keeps the rigid line outer conductor from touching that metal hanger.

The induced current that flows on all metal components near an active FM antenna can cause a potential difference to occur between that bracket and that copper outer conductor.

This then can cause an arcing to occur between the bracket and the coaxial outer, and can result in a burn causing an external hole in the coax. It shows up because the antenna starts losing air pressure.

At the shop, we have a drawer full of these buttons. When we return to antennas like this one, we have some of those buttons in our pouches – we replace them if necessary.

By the way, I would suggest using Teflon buttons. I have seen manufacturers that use nylon buttons – buttons which will melt in high RF fields. We will only replace them with Teflon buttons.

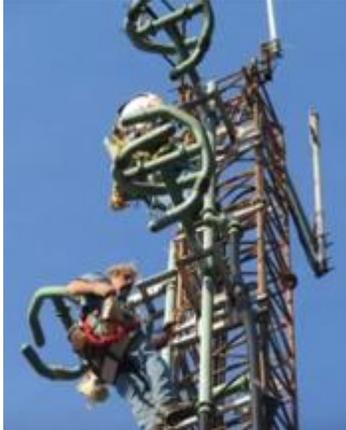
This side-mounted antenna is an example where we reported the insulators had started to deteriorate due to solar exposure after 25 years. You could see where they were leaking and where they were layered.

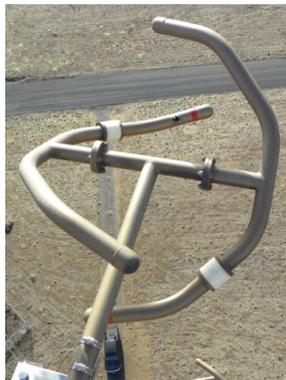
Usually it is the result of someone attempting to shoot out the tower lights with a gun, but instead of hitting the light, the bullet hits the antenna or the antenna feed line. The hole is usually right where the lights are on the tower.

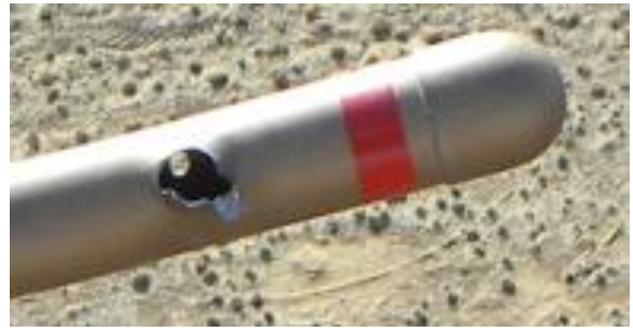
If the feed line is flex line, you cut the jacket off and put a piece of copper strap around it, soft-solder the strap to the copper outer conductor, and you are back in business.

On the other hand, if the bullet just glances the coax or goes through it leaving a bullet hole, you can go up there and repair the hole.

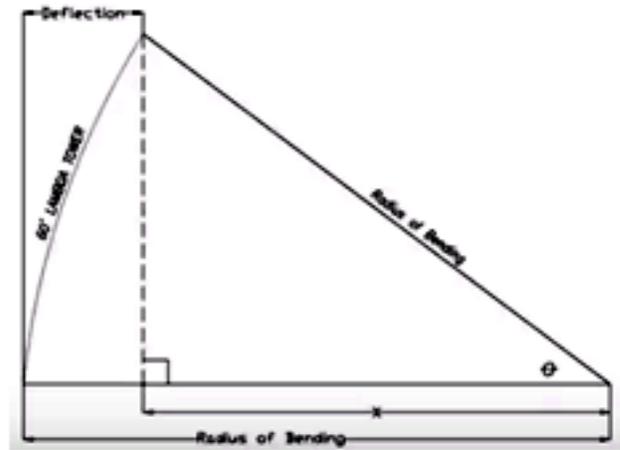
You can see in the example above that the tower forms an arc and the radius of bending is the same at the top as it is at the bottom. I published a paper on this years ago because everybody kept asking how you calculate uniform tower deflection.

Again, in the example above, I have assumed a 60-foot tall tower and specified a 3,000-foot radius of uniform curvature to keep from hurting the antenna.

From trigonometry, the angle in radians, Θ , times the radius of an arc is equal to the length of the arc. The distance of X is the horizontal distance to where the tip of the mast moves horizontally in the wind.

Using trigonometry, one can calculate the deflection of the tower section if the deflection is uniform. In this case, the top of the tower moved 7.2 inches when the tower bends uniformly with a uniform bending radius of 3000 feet.
