# Broadcasters' Desktop Resource

## The Worst I've Ever Seen! The Tower Leg that Just "Melted"

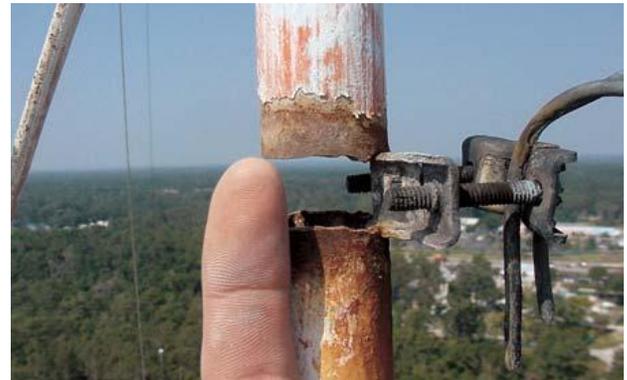
As the climber got closer, the view became even less appetizing. It indeed *was* what he thought he had seen – a rather nasty gap in the leg.

This tower leg wasn't designed to have a window

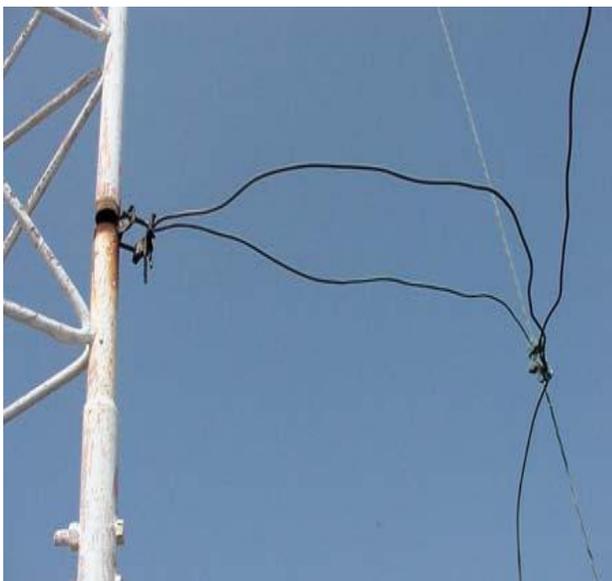
As you can see from the condition of the tower and paint, over a long period of time, something "ate away" the metal.

One of those truly  
"it is hard to believe your eyes" situations

Obviously, the electro-chemical reaction, aided by the pull of the unipole supporting wires did a good imitation of a hot knife going through butter.

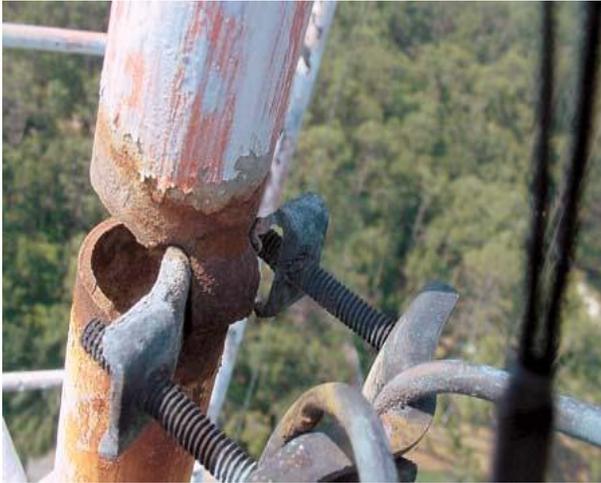
By the time when these pictures were taken, only the bracket itself was holding the tower leg in place.

**Only a tiny, buckled bit of the tower remained**

It was only a small gap, obviously hard to see from ground level. But with only a tiny, buckled bit of the tower leg remaining, the gap would have been more than large enough to bring the whole tower down if any stress from high winds, for example, had occurred.

Barber relates that the climber stopped what he was doing and got off the tower immediately. Repairs to the tower were carried out shortly

thereafter, and at last report, the structure was stable.
