Broadcasters' Desktop Resource

The Worst I've Ever Seen! **A Towering ... Tower?**

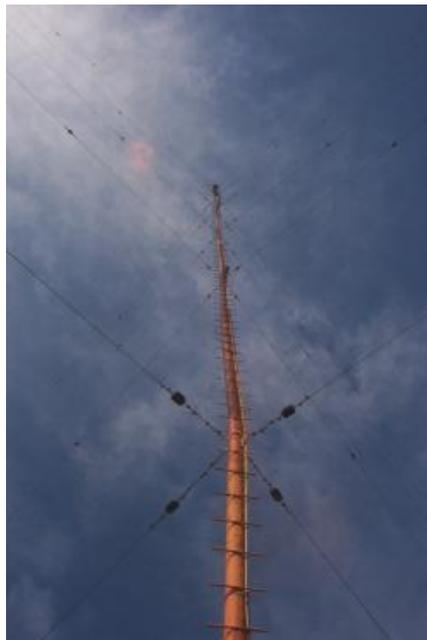
**It does not take a surveyor's transit
to determine this stick is not quite plumb.**

Getting closer to the structure, Rother understood why it looked as it did. “The “tower” appears to be made of six 30-foot oil drilling shafts that have been welded together, and foot pegs welded on for climbing.”

He continues: “The “tower” is guyed from four sides instead of three, with the guy levels appearing to be at each joint in the drill shafts. The base of the “tower” is suspended by what appears to be high tension power line insulators mounted from the “tower” to a triangular mount that has legs that go into the ground.

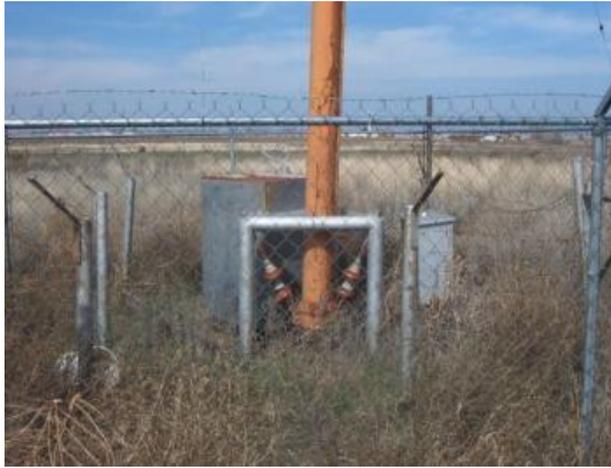
**Perhaps this is not a typical tower installation.
The ground, by the way, is level, the tower is not.**

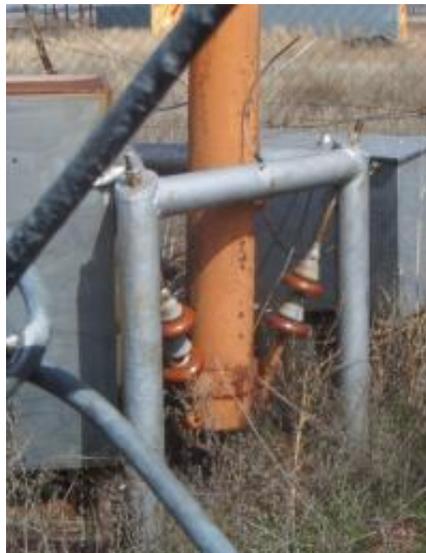
“The base of the "tower" is suspended in such a way that there is nothing but earth and grass directly below the "tower" itself. The "tower" appears to have once been lit, but when I saw it, it had no electrical power crossing the base insulator.”

**Apparently, this tower was supposed to be
suspended with nothing under it at all.**

At least, the station was probably free from citation for tower fence issues. Rother noted the chain link was in good condition, with one run of barbed wire at the top.
