Obsoleting of Facility Electrical Grounding Protections

19 May 2022

GroundLinx® Technologies LLC

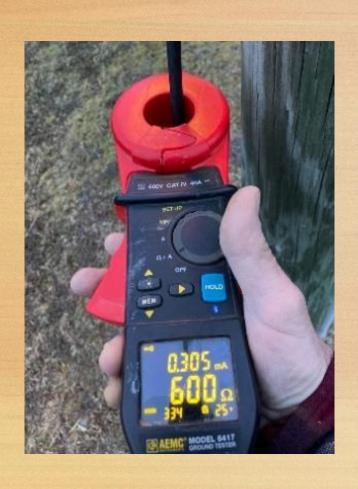
Soil and Measurement Practice Failures

Main Distribution Panel	17.25
Gen 1	17.26
Interior Main Panel	17.23
Battery Room	17.25
Main Power Supply	17.24
Raised Floor Pedestal IT Room	17.23
Mechanical Panel Room O	17.21
Telephone Room Ground Bar	17.04
Equipment room under floor ground conductor	17.05
Equipment room large ground bar	17.04
Equipment room large ground/buss bar east wall	17.04
Telephone room raised floor pedestal	17.14
Telephone room buss bar east	17.17
Battery room raised floor pedestal	17.17
Electrical panel battery room	17.16
Battery room panel F	17.23
Battery room panel M	17.17

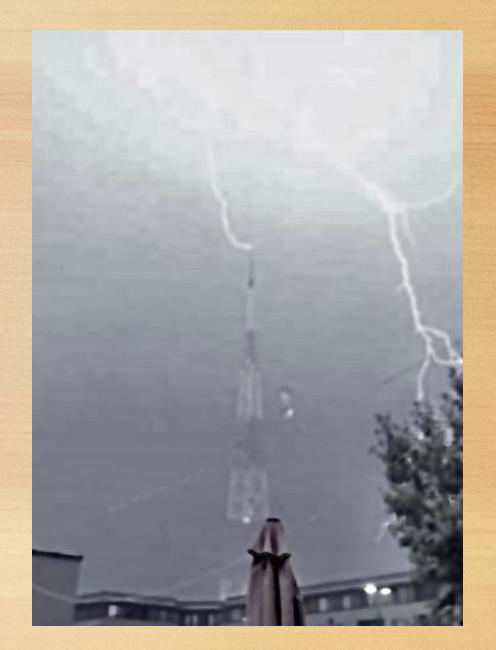
... Even if it Looks To Us Like This

- TV Tower
- August 2021 strike
- No down time
- Lost one camera motor
- Upgraded grounding system had just been installed.
