Bad Axe Mixer: A Blast from the Past

By Michael Hahn

[August 2021] At one time, it was common for broadcast engineers to build everything from consoles to transmitters and antennas. Lurking in many stations' basements are some interesting relics. Michael found one and decided it would be an interesting project to restore it.

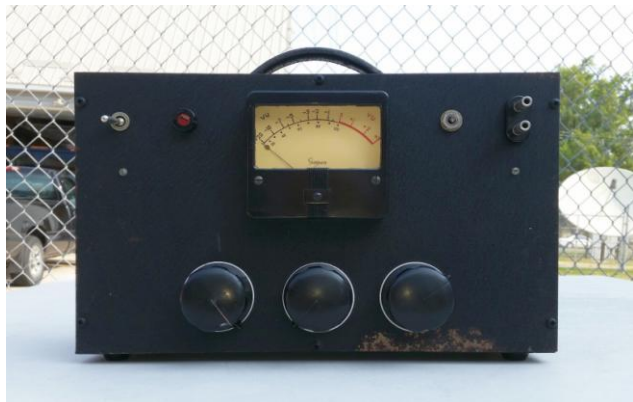
Front view of the Bad Axe mixer

There were no labels on the mixer, but its operation is so simple, they are not really needed.

The two left-hand knobs are the microphone input levels, and the right-hand knob is the master level control.

The phone jack in the upper right is for Hi-Z headphones, and the banana jacks connect to the phone line to send the audio back to the station.

The large, illuminated Simpson VU looks impressive above the RCA style knobs.

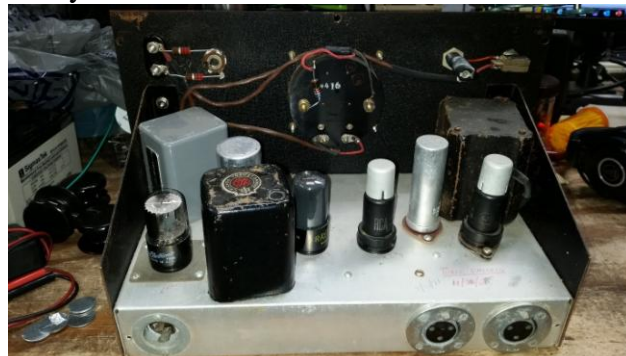
To the designer's credit, he did use quality transformers, with decent magnetic shielding. But in an audio preamp circuit with lots of gain, hum finds its way in through unpredictable paths. Shielded tubes (6J7's) were used, with shielded grid capacitors and shielded grid wires.

The 120 VAC wiring is shielded, as are the microphone input wires and the line output wires. Hum was definitely on the designer's mind.

As a side note, the input transformer is a UTC LS-10X, and was considered a good quality

Rear view showing AC power socket, microphone inputs, tubes, transformers, etc.

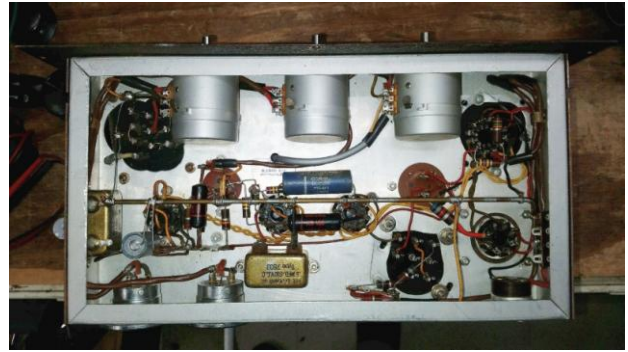
The microphone input connectors are old Cannon P-13's, the predecessor to today's XLR's.

They connect directly to the Daven attenuators on the front panel.

Inside the chassis. Notice the Daven pots

These Davens are 50 Ohms input, 100 Ohms output. I have no idea what type of microphone they thought would match into a 50 Ohm input. None that I know of will – and there is not enough gain in this preamp to work with ribbon microphones.

The 100 Ohm outputs of the Daven's connect to opposite ends of the input transformer winding, which is strapped for 200 Ohms. This is a screwy setup, and I do not believe it works well (even if the Z's were appropriately matched). The microphones are unbalanced, so they have no ability to reject common mode noise from external magnetic fields.

The 50 Ohm Z is so low that it will severely load any normal dynamic microphone, collapsing its output voltage, and probably causing loss of any low frequency response. Additionally, the circuit causes intermodulation by impressing a portion of the output voltage of one microphone onto the other microphone.

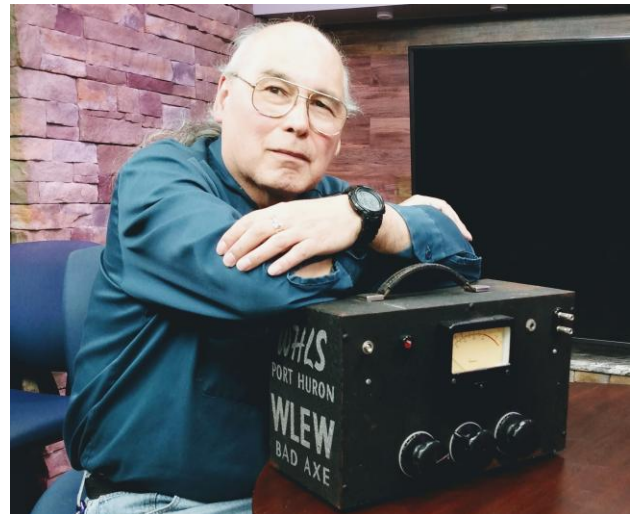
Ready for action!

With only three knobs, the operation was quite simple. As I had expected, the low frequency response was not great.

With that problem solved, I connected a microphone to the input using a 200 Ohm dynamic microphone to feed the 50 Ohm input, but it was perfectly adequate for the intended purpose.
