On the Road with an ABIP Inspector Part 3 – Main Studio Gear, Tower Color, and More

By Mike Langner

[August 2013] Here is another in our continuing series showing how the Alternate Broadcast Inspection Program works.

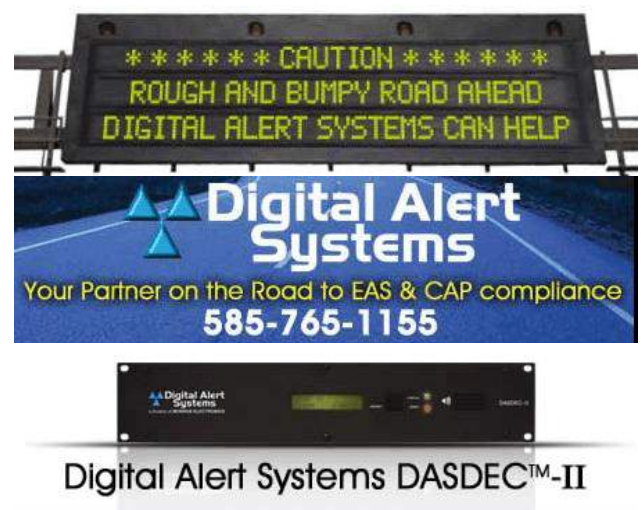
Not too long ago I went to a station which had had its tower painted. The steel was covered, but there was a minor problem.

The tower crew, no doubt the lowest bidder, started painting at the top, which is the usual procedure. Unfortunately they ran out of paint before they finished, so they dispatched someone to run off to Home Depot and purchase some more orange paint.

From what I could tell it was highway safety orange. It was certainly not the proper FAA Aviation Orange as required by both the FAA and the FCC. ([Click here to see Ed Trombley's discussion on paint, painters, a link to the FAA specs and other good information.](#))

After I showed the broadcast company my paint color chart, they had the tower re-painted with the correct color. Want to buy your own chart? They are available from Hale Color Charts, Inc. at 800-777-1225.
