Broadcasters' Desktop Resource

High Powered History Growing Tower Farms in M/SP Part 4 – Finishing Touches and On the Air!

By Steve Brown

[November 2015] We bring our look at the Minneapolis-St. Paul Telefarm and Shoreview sites to a conclusion as Steve Brown shares the rest of the story of how these sites developed.

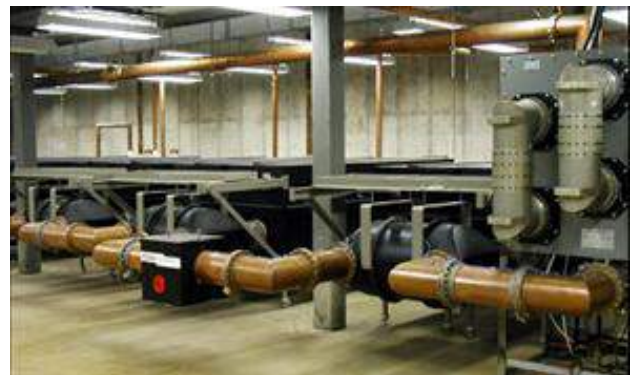
After the dummy loads were repaired, the technician from Britain that Alan Dick sent to tune up the combiner wound up spending most of the winter getting things adjusted.

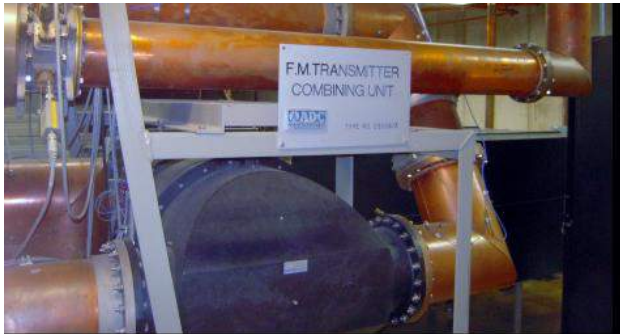
Unfortunately, what we found was the combiner parameter measurements taken when the system of the s cold would drift as real transmitter power was applied to the modules.

Part of this was problem due to our specification that the combiner system have very good phase response across each station pass-band (group delay) as well as amplitude response. We also required that station-to-station isolation through the system did not rely on any turnaround loss in the transmitters, since no transmitter manufacturer had specified that parameter at that point.

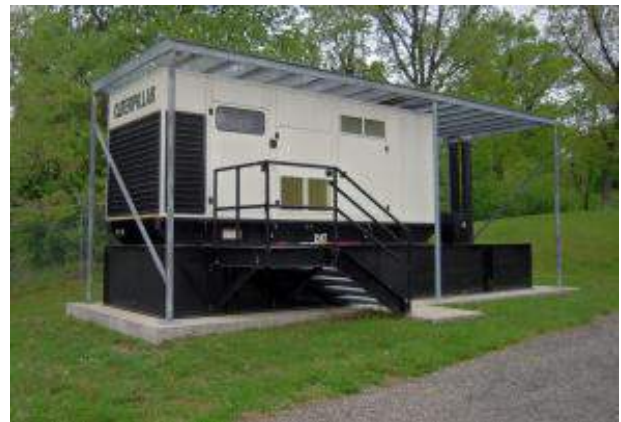
The 1 Megawatt generator, ready for action

Additions: In 1997 station #9, then WXPT-FM, 104.1 MHz was added to the combiner string. And, as we had preplanned for emergency power, during 2006 a 1 Megawatt generator with lots of fuel capacity and transfer switches was added to the site.

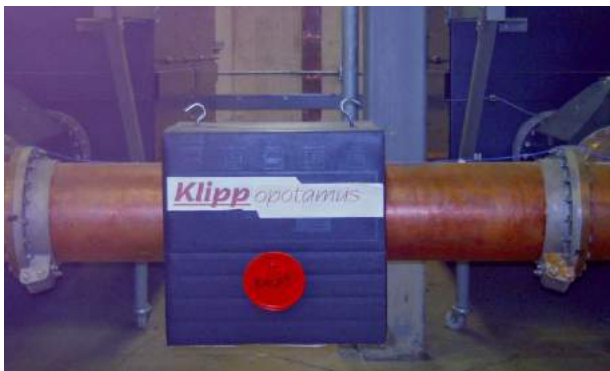
The World Famous Klippopotamus on guard

Intrigued by Bill’s imagination, we decided to go a giant step beyond the diodes and create a passive audio clipper that worked in the RF domain. We set the “Klippo” up to process *all* of the stations by clamping it to a section of 9-inch rigid transmission line, supposedly making the playing field really even for all stations.

The Klippo is still on site after all these years, “guarding” something.
