The Maintenance Shift Solving Some HT 3.5 Troubles

This particular transmitter was a 1992 model HT-3.5, now in service for about 20 years. A quick check with the remote and sure enough it

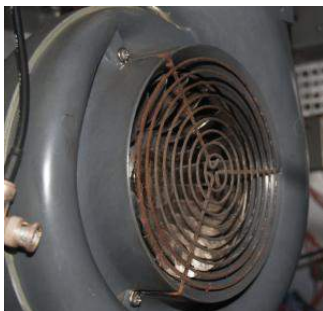
During the late night return trip, after shutting the transmitter down and taking all safety precautions, I cleaned the transmitter up and put in the new tube.

By the way, I normally do my major cleanings with each tube change. But this previous tube had a long life: 128,652.7 hours – or over 14.6 years of 24/7 operation. So the cleaning

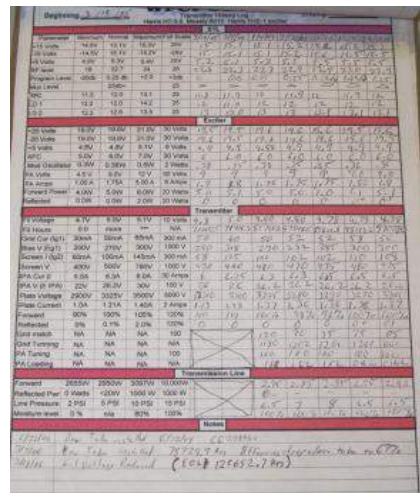
Looking back at the transmitter’s history it was actually very easy to spot the trouble. You may have heard this one before but it bears repeating: as part of your documentation, keep a history of the transmitter meter readings. This experience proves why.

Some of the readings stood out from the normal numbers recorded over the years.

Carefully noting the deviations from normal, the voltage to the solid-state IPA was way up.

This condition caused excessive power output from the IPA, seriously overdriving the grid of the tube. Luckily the tube showed no signs of damage from being overdriven, but it easily could have killed a good tube.

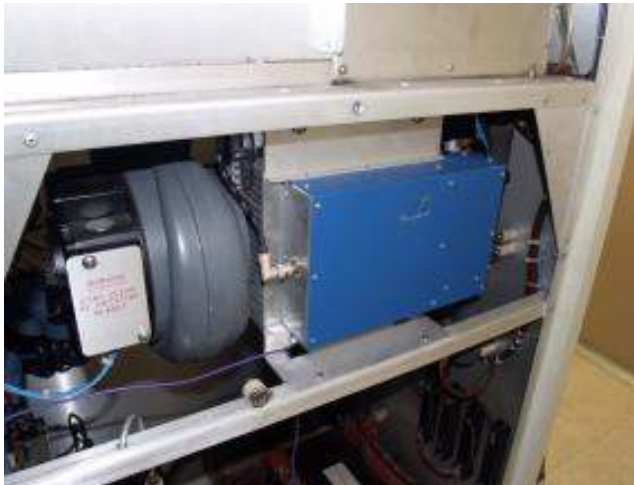
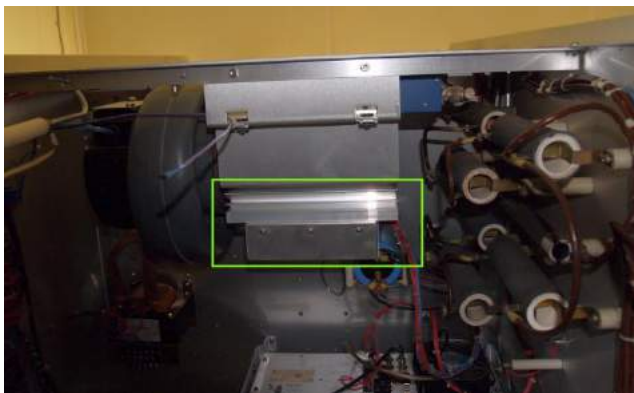
After a bit of looking, the regulator was located mounted directly behind the IPA module, in the intake airflow of the PA blower.

When I first looked at the mounting position it seemed like it would be rather difficult to access and repair. When in reality it was not that difficult at all.

By simply removing the IPA assembly from the transmitter and then removing the screws securing the support panel it was attached too, gave quick access to the IPA.

The down side is that the wires attaching it are not easily disconnected and it is easier to repair the regulator while it is still connected.

To do that I separated it from the support panel and stood it up on a rail and slid it to the side, lock-ing the heatsink securely into transmitter back frame.

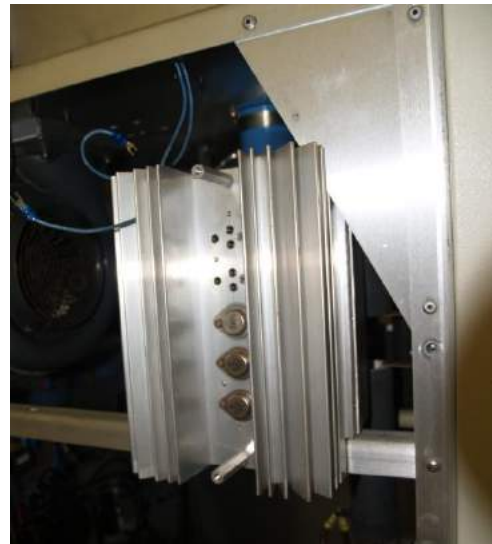
To start the repair all of the MJ15015 transistors were removed from the heat sink along with the LM 317 regulator. Of the four transistors, one was found shorted and another was found to have an open base.

One thing I found that turned out to have major importance was learning that the heat sink compound had dried up, likely causing excessive heating for the transistors. My guess is the open base failure occurred first, at some unknown time, putting an additional heat load onto the remaining three transistors. Coupled with the loss of cooling one of those transistors finally gave up the ghost.

When reinstalling the replacements I replaced all the mica insulators with Sil-Pads which eliminated the need for heat sink grease. The reassembly was quite painless and the transmitter tuned up nicely once it had the proper grid drive.
