Clear Channel's ERT Restores Signal to Dickinson, ND

[June 2011] The storms that thrashed the middle of the US in May and June brought floods, tornados and more problems. As stations all over the region struggled to recover – and in many cases get back on the air – the actions of a Clear Channel Emergency Response Team shows how to do it. Our thanks to Erik Kuhlmann, Regional Engineering Manager in Portland, OR for the information and pictures.

At approximately 10:00 pm on June 1st, the KZRZ/KCAD guyed tower catastrophically failed when a saturated hillside near Dickinson, ND gave way.

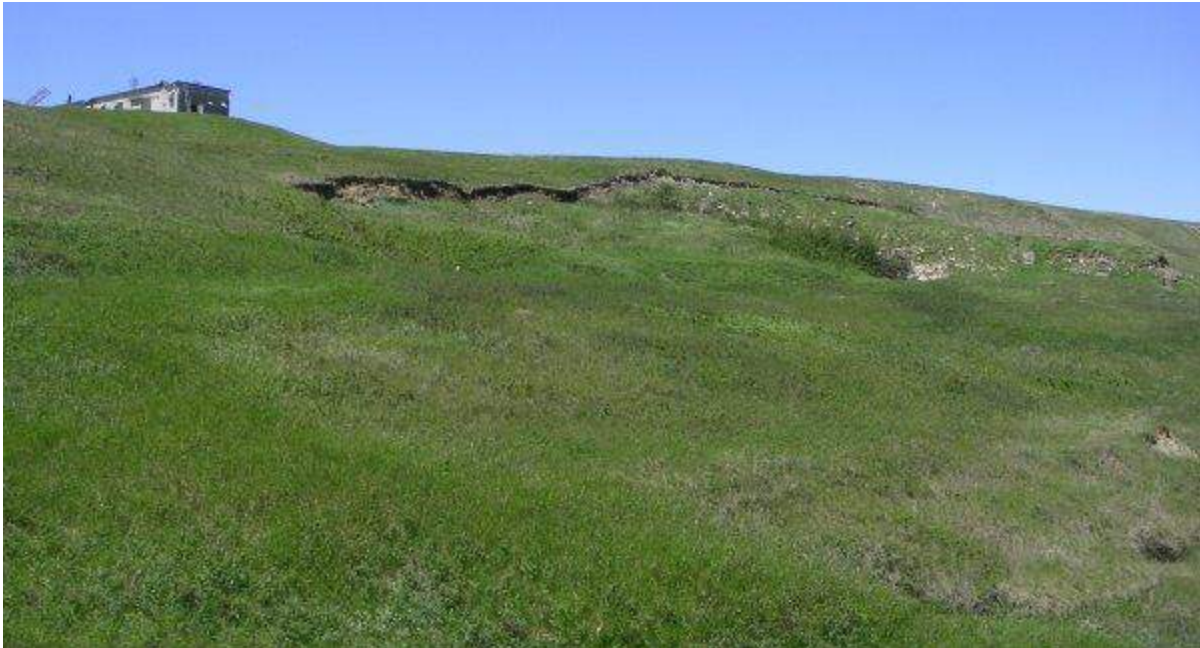
The cause of the trouble to KCAD and KZRZ. Not only did a significant drop occur, but if you notice, a large area was affected.

As can be seen, a large patch of land just slid down the hillside. This caused a guy anchor to give way, with the tension from the remaining guys pulling the top half of the tower too far off plumb and resulting in a total collapse of the tower.

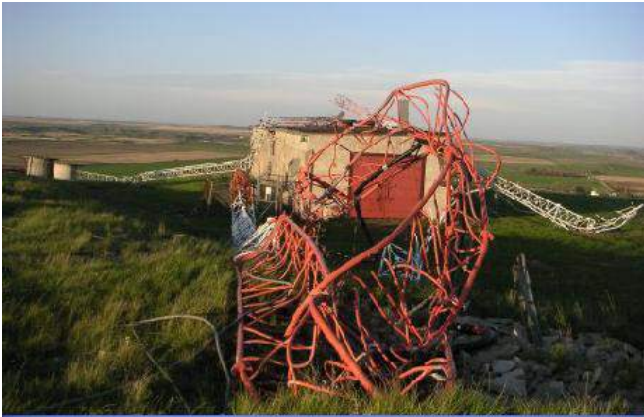
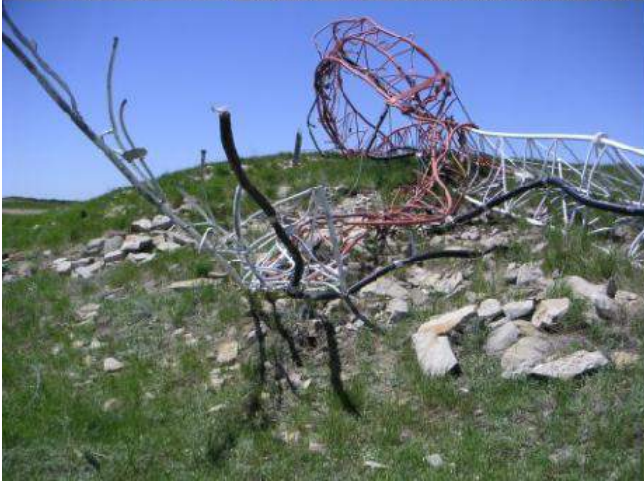
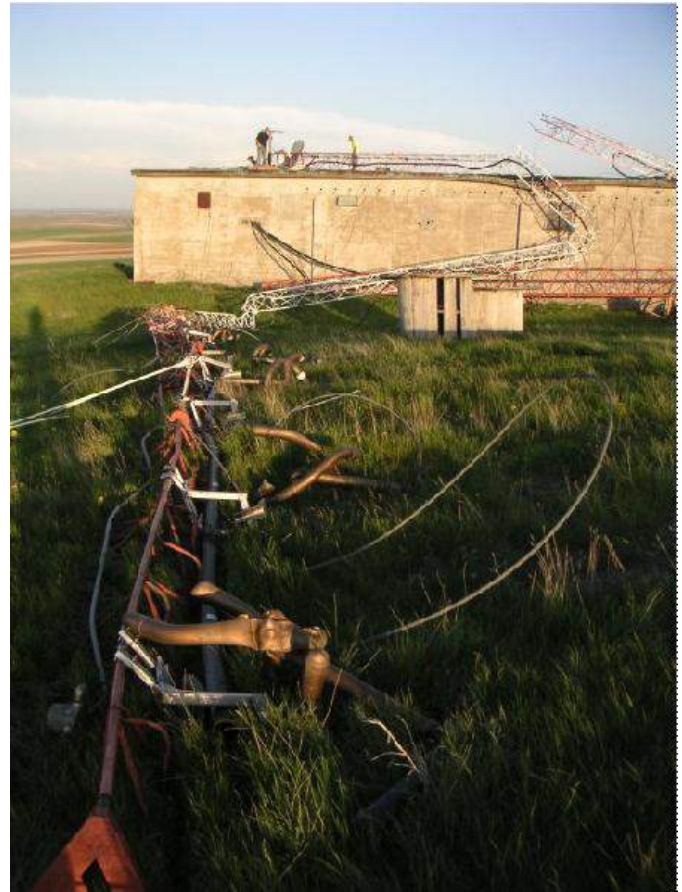
**The tower suffered catastrophic failure from a guy anchor failing.
Both KCAD and KZRZ were knocked off the air.**

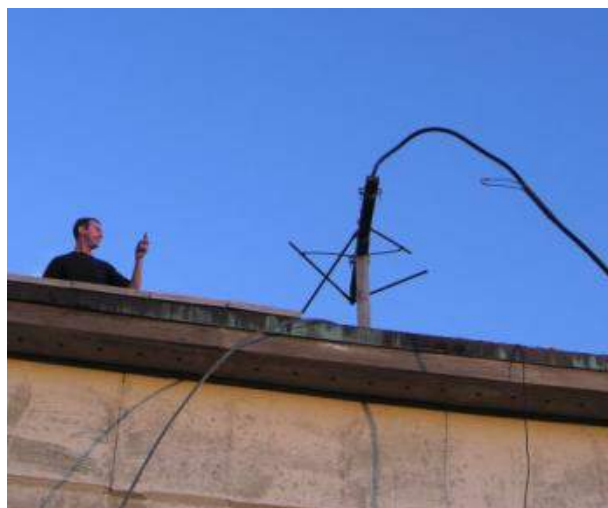
While waiting for the other replacement antennas and parts, Steve George got started and with the other engineers, put an old antenna to use, mounting it on the top of the transmitter building. It was not the prettiest antenna in town, but KZRZ was back on the air with a couple of hundred Watts from the auxiliary transmitter by 8PM the following evening!

Truly an "Emergency Antenna" ... but it got KZRZ back on the air in less than 24 hours from the disaster.

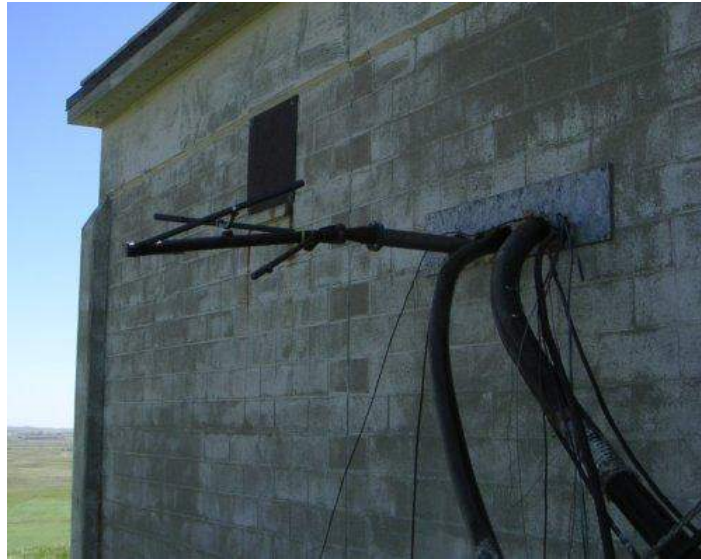
Next it was time to get KCAD back on the air. Another old antenna bay was located, along with a spare STL dish at the studio and with some retuning of the KZRZ main transmitter (which had been dragged across the floor by the heliax when the tower fell) to KCAD's frequency – and voila! – another station with a weak but usable signal to reach the local audience was up and on the air by Midnight.

Again, not pretty – but it worked!

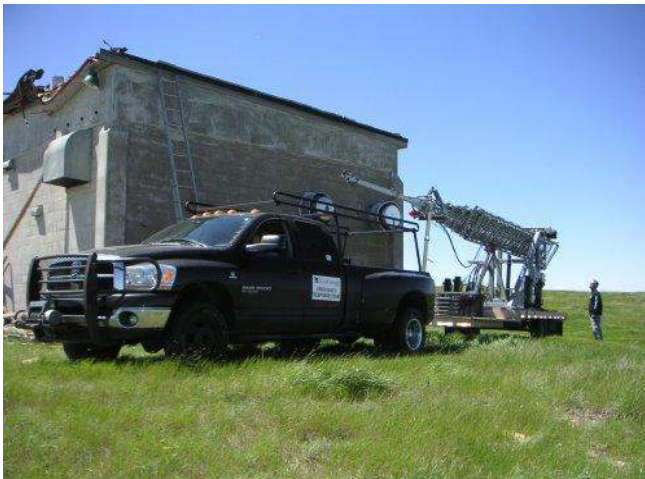
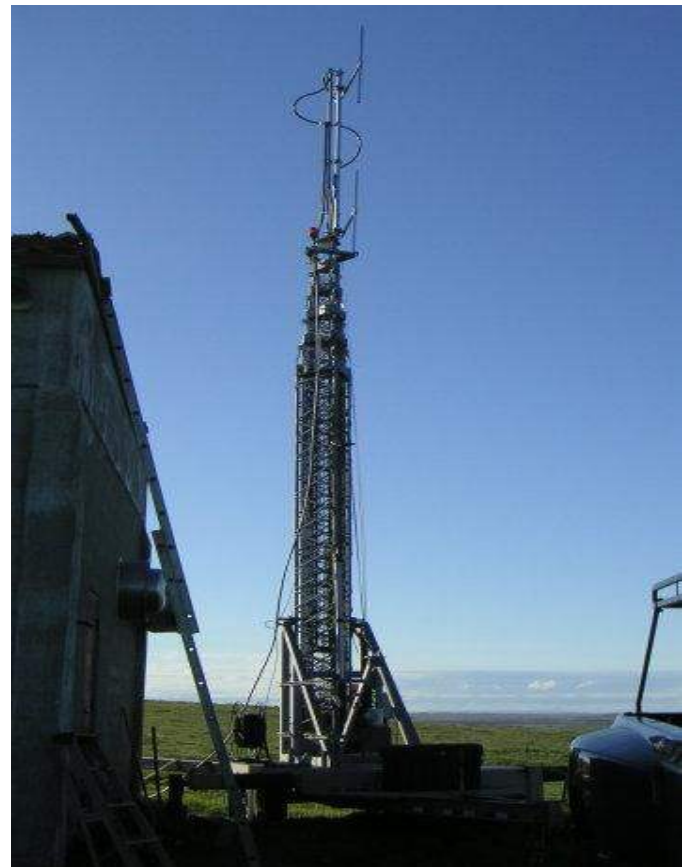
By the third day, Allan Brace arrived from Tulsa with the ERT Truck, including a portable tower and parts. With more repairs, the crew had one station on the portable tower - and audible for 50 miles - by the next day. The following day, a short piece of the original tower was cut from the damage, set up, and the second station was moved to the temporary tower.

The next step, of course, was to survey the land and see about setting up a new tower. The tower and antenna is already on order and by mid-July, the stations should be back to full power!
