Broadcasters' Desktop Resource

Replacing Hard-to-Fit Electrolytics in Video Monitors (...or anywhere)

By Scott Todd

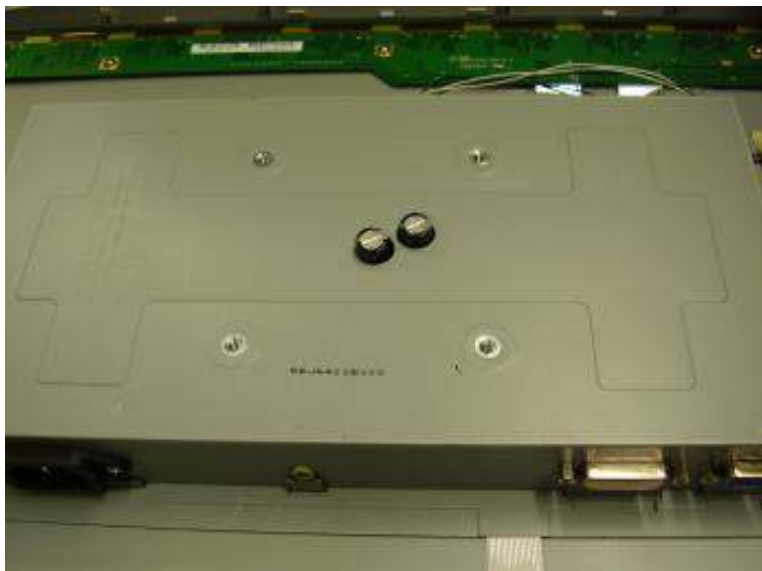
We had an off-brand flat-screen monitor in our station that quit working after blowing five electrolytics. After inspection of the motherboard, it was clear the manufacturer did not use ones that were of low enough impedance - so I ordered some replacements that were of the appropriate value.

Unfortunately two of the capacitors were too tall to fit under the cover, as there was no room on the board to lay them down. Unwilling to just give up and buy a new monitor, I took a unibit and punched holes in the chassis to allow room for the tops of the cans.

**All too often a replacement part will not fit perfectly.
A well-placed hole in the case solves the problem.**

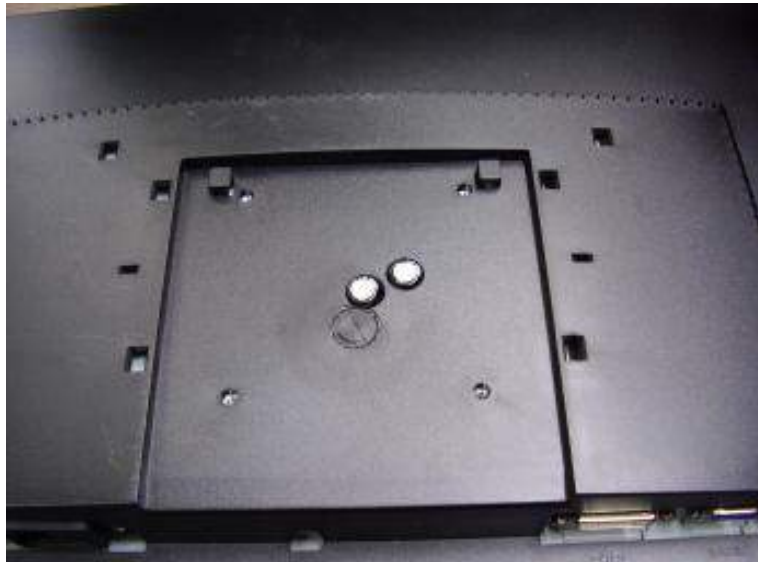
As is common with most all consumer electronics, space is always at a premium. So, even with the holes made in the motherboard case, there still was the problem of fitting the electrolytics inside the plastic back of the monitor itself.

Another set of carefully placed holes in the back of the monitor provided the way to solve the problem completely.

Another set of holes, and it all fits together.

As shown in the picture, everything fit back together quite nicely – and the monitor was working well once again.
