# Broadcasters' Desktop Resource

## Before and After

### Toward Safer Tower Lighting Systems

*[April 2013] This is the first in a slightly different sort of series: a discussion of how danger points, major problems, code violations, or other issue were resolved with a plan and minimal cost. First up: a solution for an electrical code violation.*

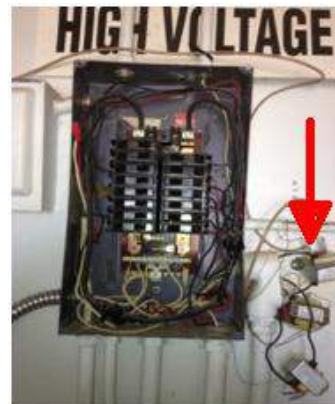
At an undisclosed location, someone mounted tower light current-monitoring transformers in a way that is not described in any electrical code book I have ever seen.

As you look at the picture, these transformers are on the lower right side.

It is not clear what high voltage there was present at the breaker box, but it is quite likely that this wiring would not pass any electrical inspection.

The first step was to mount the transformers in an approved electrical enclosure.

Then, with the wires properly in conduit, I was able to re-install the breaker box cover and the elbow cap – initially removed so the wires for the tower light breakers could be attached to the hanging transformers.

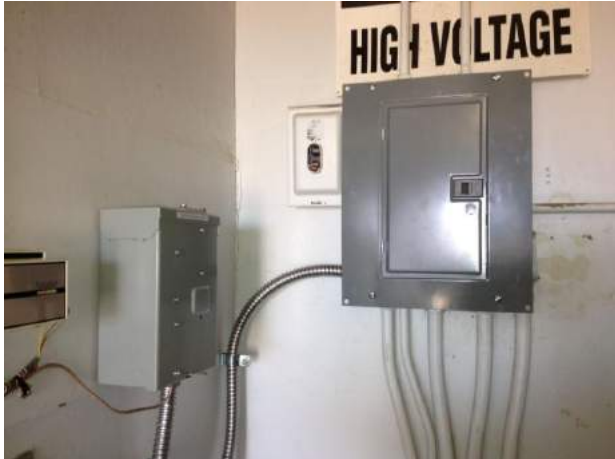
On the left side of this picture, you can see the box where the transformers were mounted.

**After the enclosure was installed the wiring looked much cleaner**

At the far left, you can also notice the low voltage sample lines leading to the remote control system.

Whenever possible, it is always a good idea to properly treat exposed wires, especially those carrying voltage or current.
