# ***Broadcasters' Desktop Resource***

## **The Worst I've Ever Seen!** **A Towering ... Tower?**

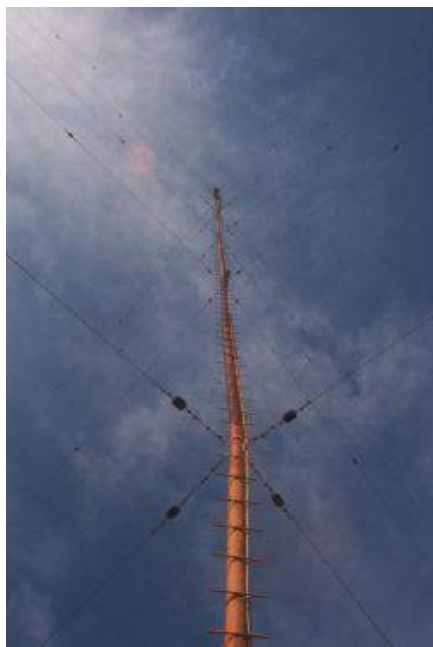
**It does not take a surveyor's transit  
to determine this stick is not quite plumb.**

Getting closer to the structure, Rother understood why it looked as it did. “The “tower” appears to be made of six 30-foot oil drilling shafts that have been welded together, and foot pegs welded on for climbing.”

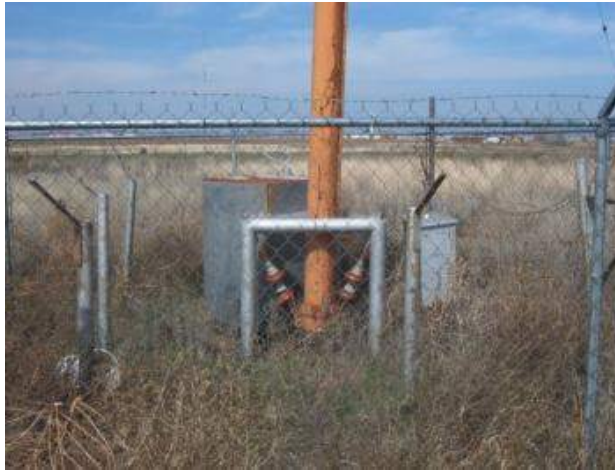
He continues: “The “tower” is guyed from four sides instead of three, with the guy levels appearing to be at each joint in the drill shafts. The base of the “tower” is suspended by what appears to be high tension power line insulators mounted from the “tower” to a triangular mount that has legs that go into the ground.

**Perhaps this is not a typical tower installation.  
The ground, by the way, is level, the tower is not.**

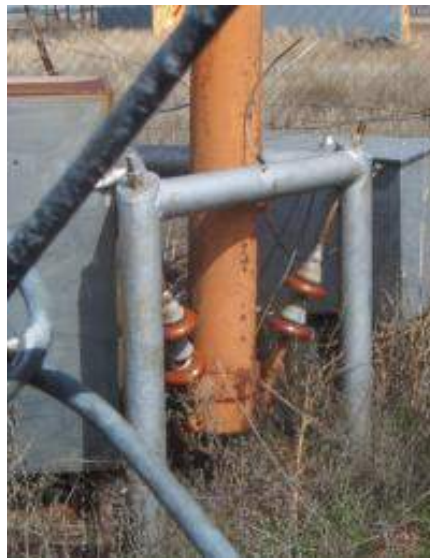
“The base of the "tower" is suspended in such a way that there is nothing but earth and grass directly below the "tower" itself. The "tower" appears to have once been lit, but when I saw it, it had no electrical power crossing the base insulator.”

**Apparently, this tower was supposed to be  
suspended with nothing under it at all.**

At least, the station was probably free from citation for tower fence issues. Rother noted the chain link was in good condition, with one run of barbed wire at the top.
