Broadcasters' Desktop Resource

The Worst I've Ever Seen!

Be Sure To Look Up!

[November 2019] When you get called out to help a station that is off-air, there is always a certain level of anxiety, if not concern, as to what you will find on site.

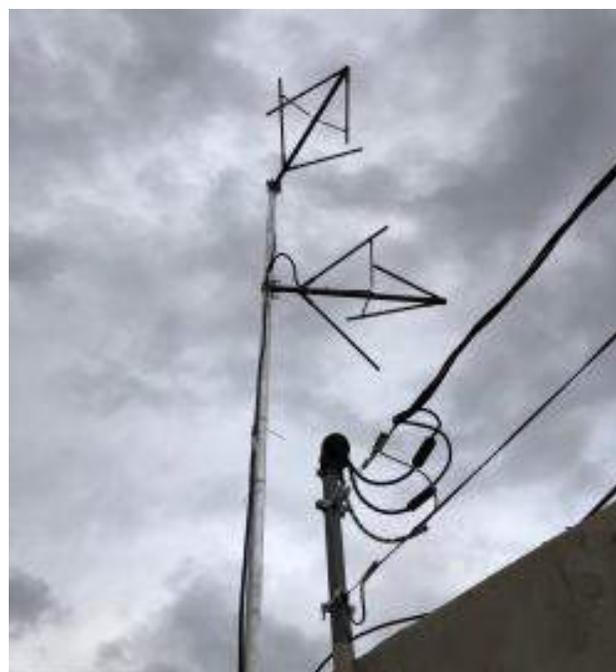
The next logical step – OK, some might say it was the first thing they would do - was to look upward. This time, there was no real question about what was going on:

Problem seemed pretty obvious at this point

Fortunately, after reducing power to approximately 15%, the transmitter came back up and seemed to happily stay up, albeit with a VSWR reading of 3.5:1 indicated. A little careful experimentation showed that 15% was about the most power one could safely run, and have the transmitter stay reliably on the air.

At that point, there was little else to be done aside from calling in someone to attend to the antenna and connecting harness. Properly aligning the antenna would resolve part of the issue, but the connectors and coax needed to be carefully inspected, to ensure the coax was not pulled out of the connector, or otherwise damaged.

Once the antenna and harness were put back to “normal,” so was the transmitter. And the hits could just keep on comin’!
