The Worst I've Ever Seen! Finding VSWR in All the Wrong Places

[October 2012] Mismatches in the transmission system can cause anything from minor bandwidth and distortion issues to completely shutting down the transmitter.

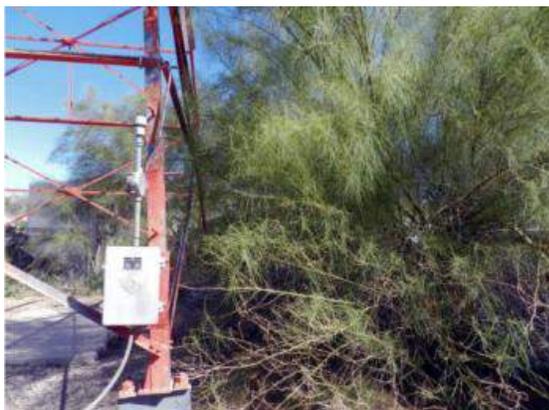
The base of this tower is no longer floating

Taking a look around the tower, it was quickly pretty clear where the problem was located.

As you can see, in this case, the adjacent shrubs, trees and weeds have grown into – and are making contact with – the tower. You might just see the transmitter building in the background.

After Stanley checked out the tower, he quickly ordered up the appropriate resources to solve the problem.

The calibrated test instruments that were required to resolve this consisted of a chainsaw, weed eater and a rake – and of course some elbow grease provided by a local gardener.

After the landscaper was finished with the vegetation around the tower, and Stanley had made improvements to the ground system, the result

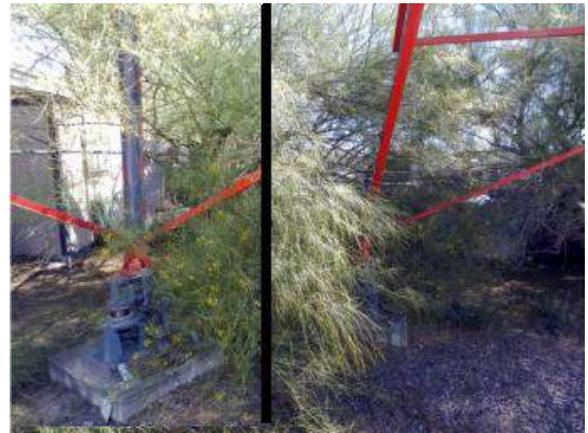
More views of the seriously mismatched tower

Obviously this problem had been ignored for quite some time and was only addressed when the reflectometer on the transmitter began to issue warnings.

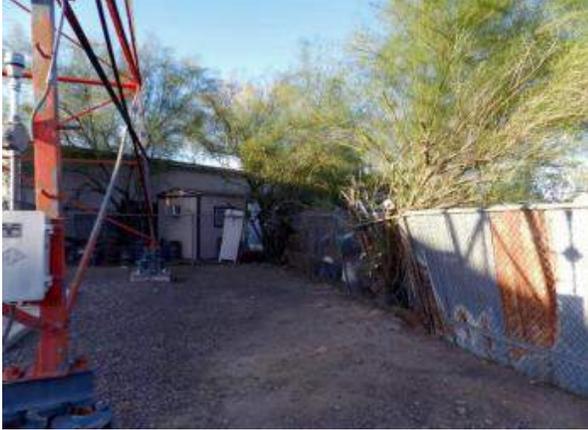
was a much calmer transmitter. RF output was up significantly.

This last photograph was taken from the same perspective as the first one.

**This is the same site
and the same position as the first shot!**
