The Worst I've Ever Seen!

Hold The Bar-B-Cue - We Need a Knife Lock!

[July 2011] Sometimes keeping an older piece of equipment running takes ingenuity. Witness the way this transmitter was kept in service until a new one was installed.

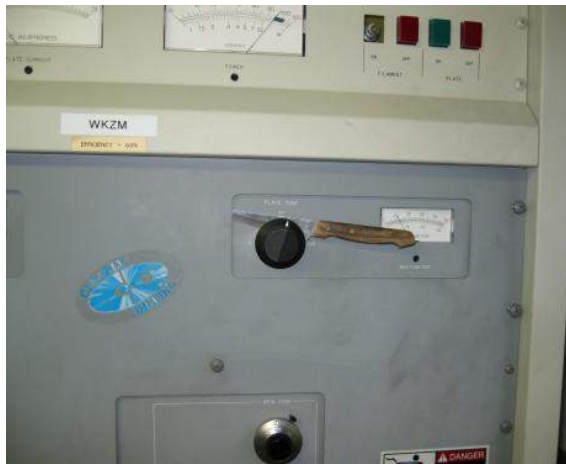
Here is a picture that shows a rather unusual use of a steak knife.

The problem was that the cabinet vibrations caused the plate tuning capacitor to move around and detune the PA.

We were told that this particular plate capacitor is manufactured with one single plate on each side. The rotor is a semicircle of silver-plated brass, connected to a shaft which supports the front panel knob. Then fingerstock was placed around the shaft to ground it.

Clearly it was gravity that was the unexpected factor. Due to the way the tuning capacitor was mounted, the normal cabinet vibrations, along with gravity, was what pulled the rotor plate out of the desired position.

At first, it was diagnosed as being caused by a poor electrical connection coming from worn out parts. So, normal maintenance practice

seemed to suggest the smart thing was to replace the shaft and fingerstock.

After replacing the shaft and fingerstock, it seemed like a good idea to apply some conductive grease. Instead, the knob now turns “real easily,” which led to understanding the problem.

Because of that, the correspondent suspects the knife will stay right there where it is until that transmitter is shut down in a few months.
