Broadcasters' Desktop Resource

The Worst I've Ever Seen! Keeping the Lights On – More or Less

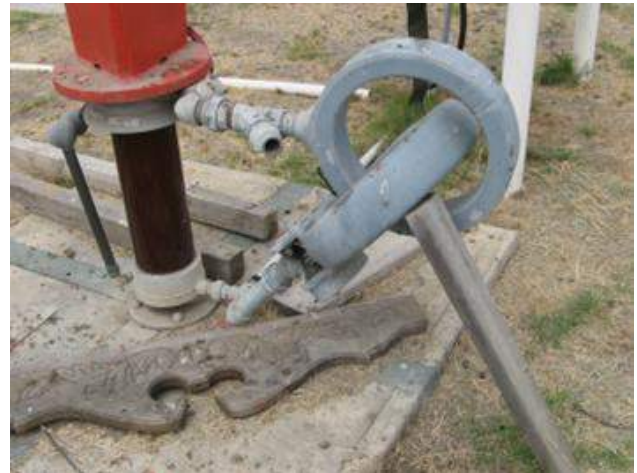
A similar makeshift approach to a solution is shown here.

Normally, a pair of Austin Rings (the interlocking rings you can see) is normally used on AM towers to get the AC for tower lighting past the tower base insulator. The size of the rings usually depends upon the load and/or tower height.

However, in this picture we see something happened to the support for the rings. The interesting part is how the station kept the lights on, while dealing with the problem.

Now the challenge is to go back and make more permanent repairs.
