# Broadcasters' Desktop Resource

## The Worst I've Ever Seen!

### Rats! The Transmitter with the Inconveniently Shorted Wire

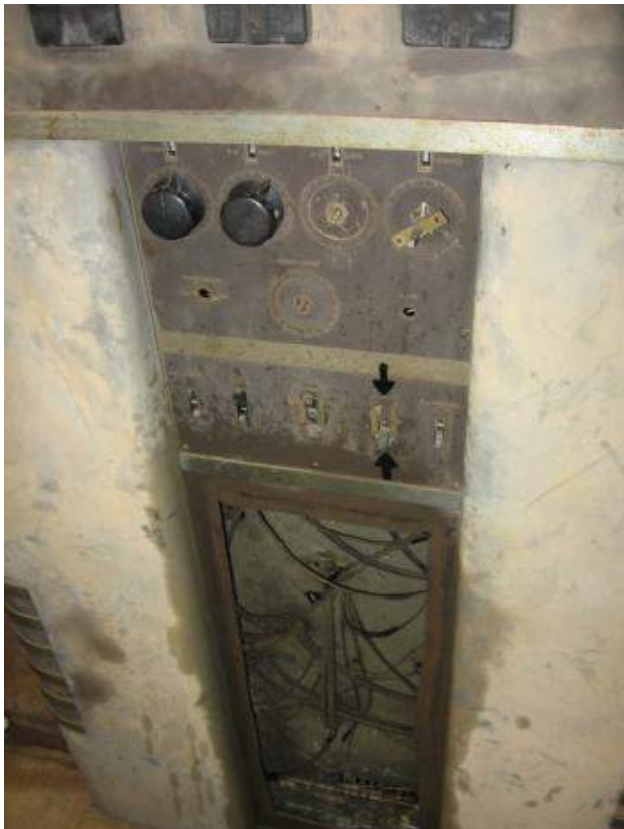
So how about opening the transmitter room door to see something like this?

Why are we sharing these pictures? Some of you may recognize that this transmitter model does not normally have a hole in the front as shown.

The location of the short was rather difficult to get to, as you can see from the picture of the back side of the transmitter. The engineer who was called found his only solution to be cutting a hole in the front of the transmitter.

Of course, transmitters of that age were not made of tin. It took six blades to get through the panel, with enough room to make the repairs.

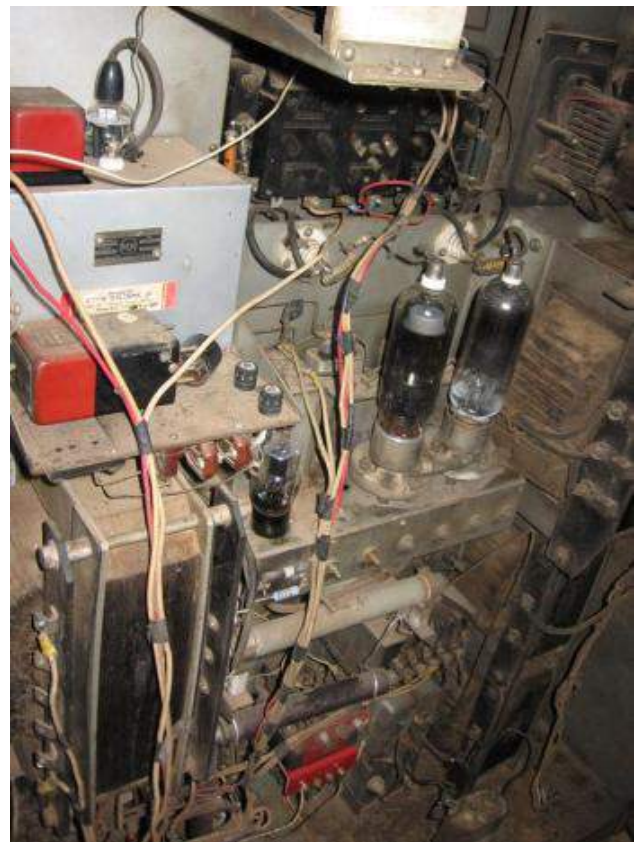
According to the story, a rat came into the room and started to eat its way through the insulation.

Eventually, enough insulation was chewed on the High Voltage transformer leads that there was a short.

The engineers on the job literally flipped a coin to determine if they were going to repair this one or tell the owner “it is time.” Twice it came up “repair one more time.”

The transmitter now is back on the air – at least for the time being.
