# Broadcasters' Desktop Resource

## The Worst I've Ever Seen! Stretching Things a Bit Too Much

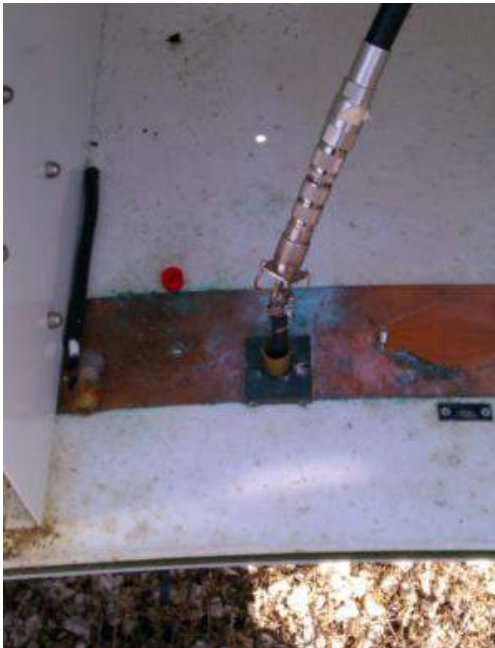
**A chain of connectors bridges the gap**

The engineer brought in to do the MoM Proof and found this surmised that the folks who installed it were trying to lengthen the cable so it could connect to the bare Type N chassis mount connector semi-soldered to the inner and outer conductors of the 3/8 inch coax line at the bottom of the ATU.

Suffice it to say the MoM Proof stopped right there! Soon, new coax will be the correct length.

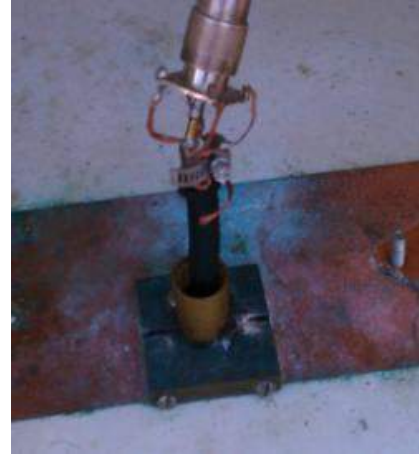
**Connected – but not very pretty**

As can be seen from the following cell phone photo (sorry about the fuzziness), five connectors were used to bridge that last three inches.

While those few inches in of themselves might not have made a significant contribution to the antenna monitor readings, the electrical loss through the connectors and the potential for deterioration of the mechanical connection just made this solution a future problem waiting to bite the station.
