# Broadcasters' Desktop Resource

## What's Wrong with this Picture?

[August 2017] It is important for a good radio engineer to be able to size up a situation quickly and make corrections where necessary.

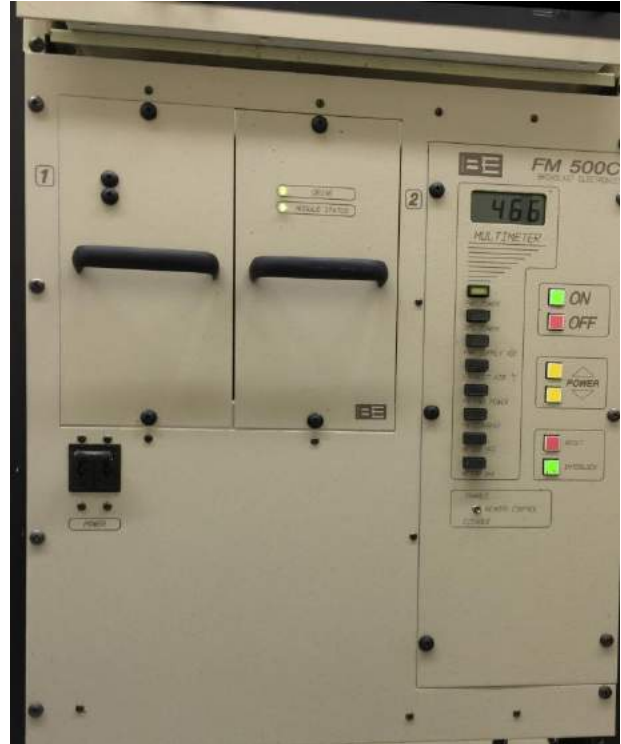
Can you tell what is wrong here? One more hint is the license: .099 kW and 2-bay antenna,

The ABIP Inspector who sent this in, says:  
“I don't remember what gain of the antenna and the possible line losses but I did the math and the station was being run at almost 4x the authorized power levels.

“It was also operating while the parent was off the air which is what really got my attention.”

A lot of folks noted the remote control disable but that was not the issue. In fact, it is much safer to disable that when you are on site.
