# Broadcasters' Desktop Resource

## What's Wrong with This Picture?

### The Tale of the Unexpected Tenant

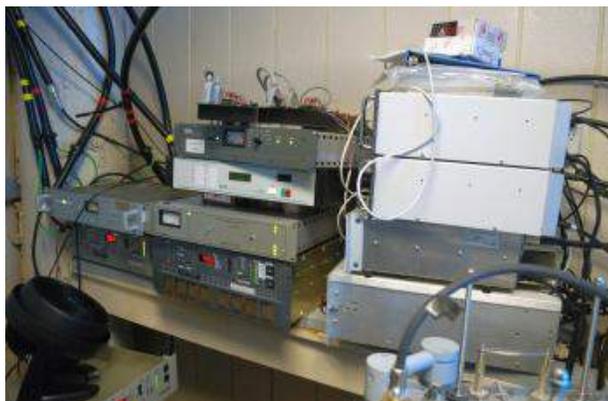
**Surprise! We're your new neighbors!**

If you look closely, you will find there are four transmitters in these piles, a remote control, some filters, and other gear – all hooked to our reader's electrical service!

In case you were wondering, apparently the senior landlord permitted access to the building although, when he checked, our reader noted that the stations were not licensed for this location, but somewhere "nearby."

Of course, our reader immediately notified his client. As this is written efforts are being made to regularize the situation.

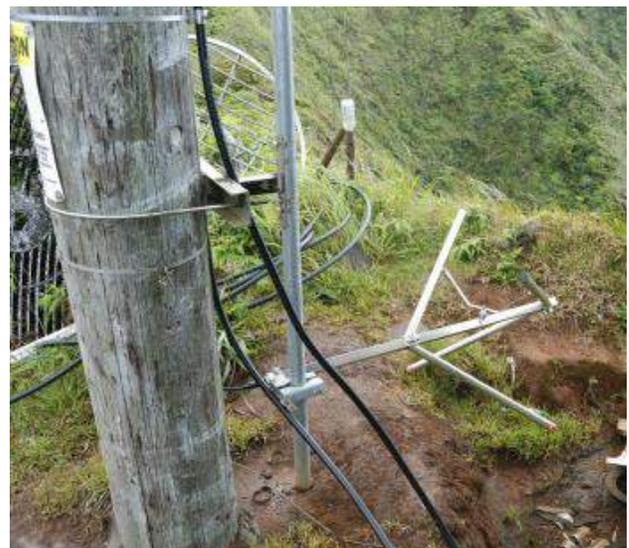
If you knew the pole outside the building was full, perhaps your next thought is "just where is this RF going?" As the engineer checked outside the building, he found his auxiliary antenna was replaced – with a three-bay antenna. Even better (well, in a manner of speech), the bottom bay was mere inches above the ground.

**Check the perspective by noting how much of the mounting pole is above ground**

It probably did not take a table or much calculation to realize there was more RF radiation than the FCC permits. But that did not seem to be on the mind of the company which installed the gear.
