Broadcasters' Desktop Resource

What's Wrong with This Picture?

[October 2010] One of the more laborious chores at many stations is cutting the grass, especially at large directional arrays. Some stations use riding mowers, others hire contractors. And a few grow jungles. Then there are those places where the job is done sort of halfway ...

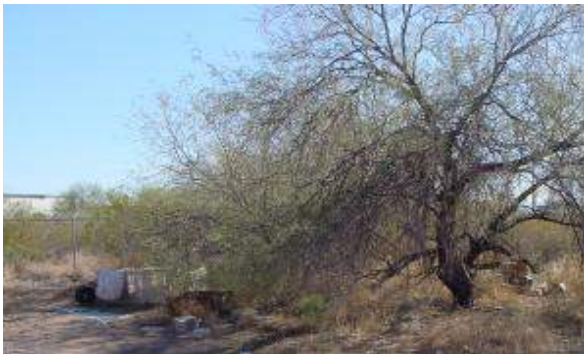
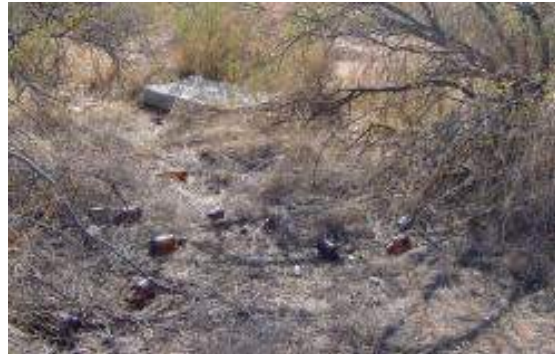
Mattresses, tables, chairs - and beer bottles – all give evidence that this tower site has had more than occasional visitors

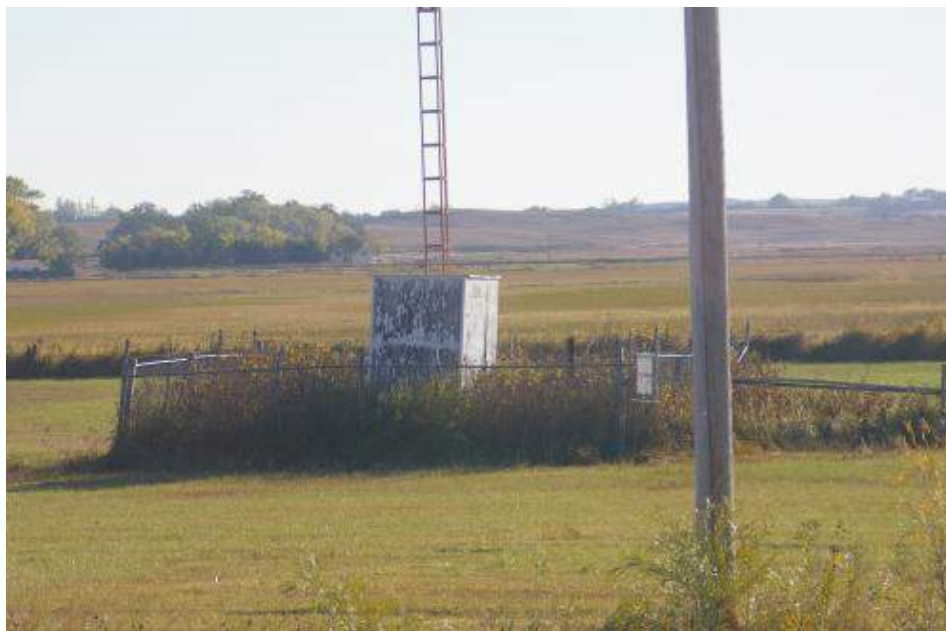
Why, yes - while the field was being kept reasonably well manicured (the edges of the field, by the fence are pretty hard to get with a big mower), the tower base area is another matter.

You can probably think of three or four good reasons that should trigger a major cleaning effort here. While the person taking the picture could not show it, it is likely some of the grass/weeds/stuff will get into the space where the arc gap is located. This could cause problems for the transmitter, shutting it down or even resulting in damage.

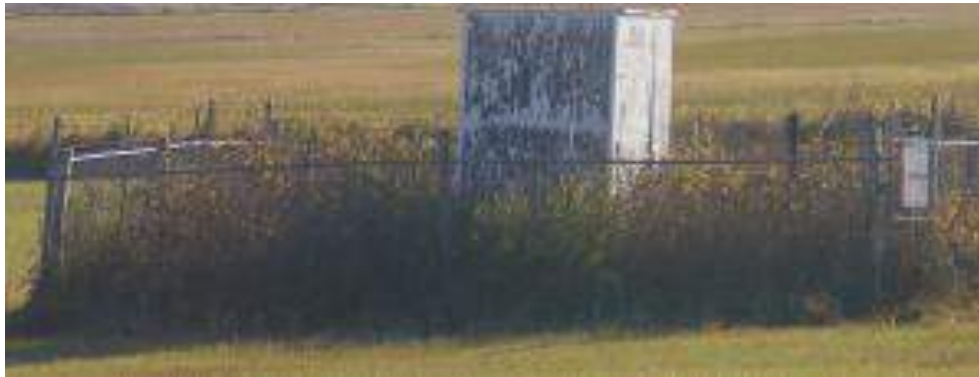
And, what do you think about the ATU shack itself? Can anyone be sure there are no holes in the sides, allowing animals or humans to get into the ATU unobserved? Furthermore, would you bet on this box being fully weatherproofed?

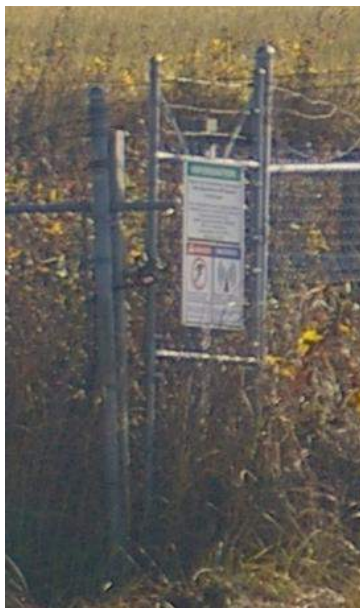
Although this gate appears to have a couple of warning signs on it, as you can see above, there are no such signs on the other sides of the fences.

And, while one doubts the gate is actually intended to open inward (!) at the moment, a closer look indicates another issue – the gate itself – that could well mean trespassers might not be kept out very long.
