Broadcasters' Desktop Resource

Tower Topics

FM Antenna Systems Maintenance: Preventing Signs of Impending End of Life Part 2

By Tom Silliman

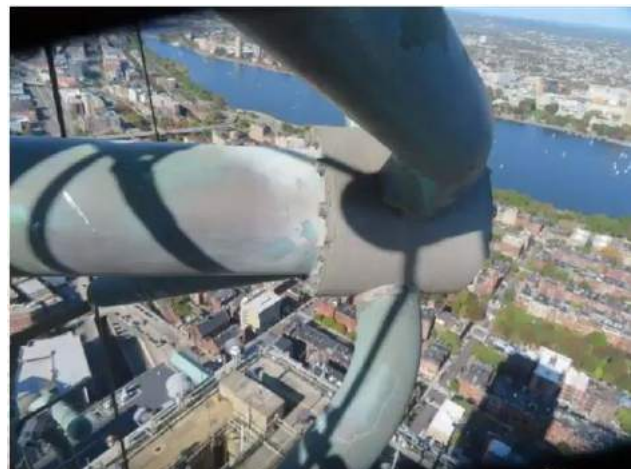
A high-power panel antenna with a rubberized paint that we use on melamine

On the antenna shown, when we realized the surface of the fiberglass was starting to deteriorate, we painted all the insulators. That was three years ago, and you can see these insulators continue to be in excellent condition.

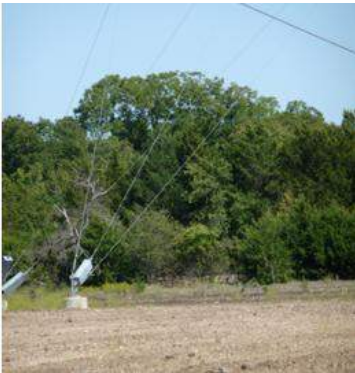
The snubber has rigid anchors on either side of the wire and has wires attached to shock absorbers that go up to the wire where a pulley is installed on the wire.

The pulley can ride up and down the wire tied to the shock absorbers. Then if the wires try to gallop, the snubber wheel subdues the movement and the shock absorber absorbs the energy. In the end, the tower it is much more stable.

Galloping wires can be avoided by introducing snubbers. If your own towers over a thousand feet, you really should consider this product.

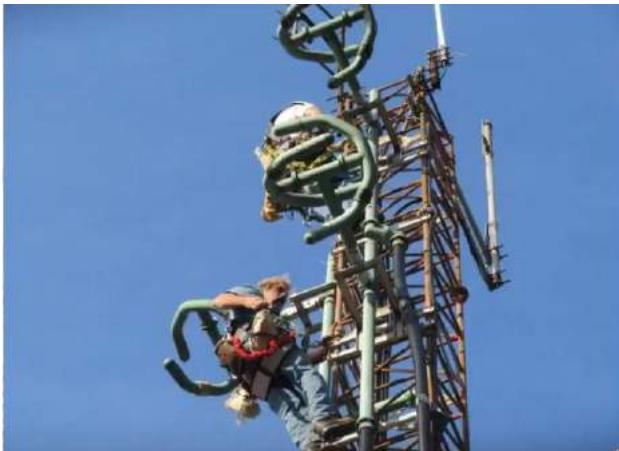
Pictured here is a side-mounted antenna:

An ERI crew at work inspecting and replacing insulators

This was an example of where we reported that insulators were starting to deteriorate due to solar exposure after 25 years. When we climbed the tower, we could see where the insulators were leaking and where the resin had deteriorated due to exposure to the sun. The outer layer of fiberglass was loose without the fiber glass resin.

We removed the worn out insulators, replacing them with new insulators manufactured with plastic rather than with fiberglass.

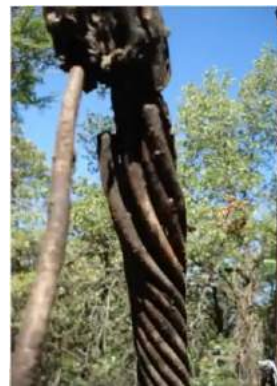
The inspection should include inspecting the guy wires for wire deterioration and the tower legs for leg steel deterioration. Unfortunately, most FM Broadcast tower owners do not schedule such periodic tower and antenna inspections.

Towers that are near to a sea coast should be inspected every five years.

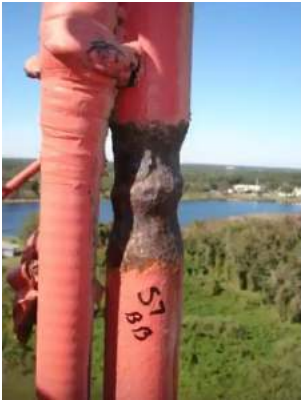
Here is an example of a tower leg in Florida where salt air has resulted in a guy wire failure. We repaired this after an inspection discovered the problem.

Another example of salt air causing tower deterioration is shown here. Here, a tower leg was rusting where the metal clamps were installed to hold a cable to the tower leg.

It is a tower leg necking that actually can be repaired, but you have got to put on external clamping that probably should be welded.
