# ***Broadcasters' Desktop Resource***

## **What's Wrong with This Picture?**

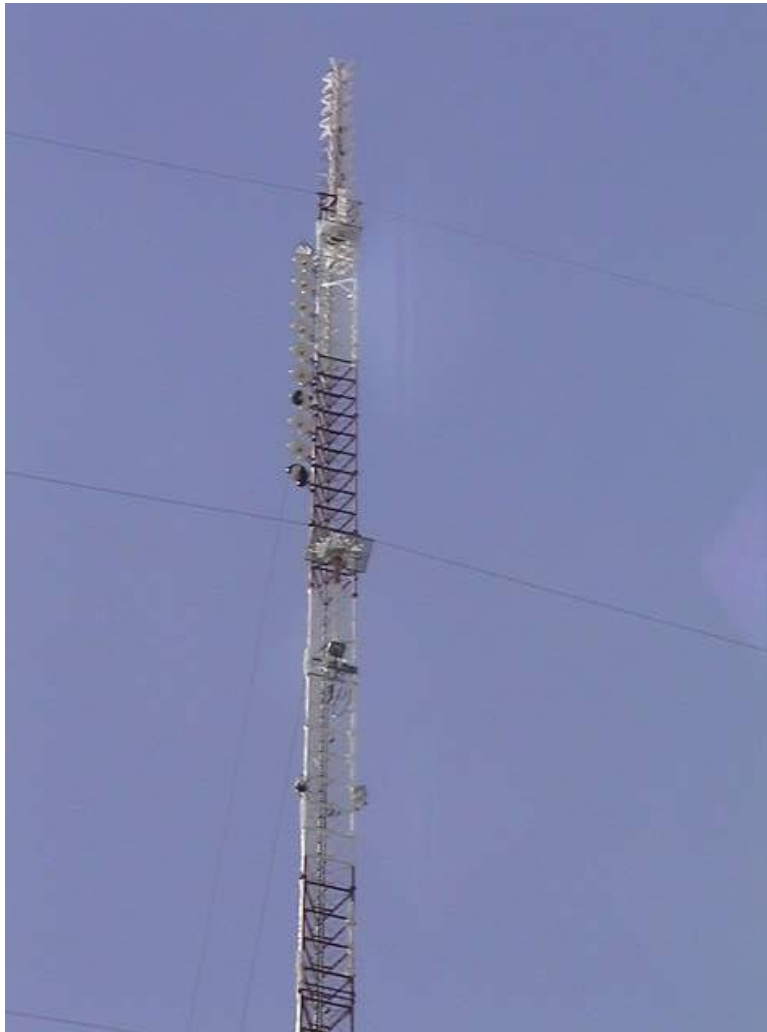
What caught my eye, and struck me as odd was that the top section of the tower was white, with a smaller orange band just below. It was not until I got up close that I saw that the top white was ice, and not a mis-painted tower (the top has to be orange per FAA specs).

One person noted that two of the antenna bays were not covered with ice, and wondered if there was a problem with the heaters or perhaps the bays were overheating themselves. Another person noted the ice-pack itself and the lack of ice shield (which might actually be down lower on the tower). And, it was commented that at least one of the sidelights appears to be covered by the ice, too.
